Benefits of GIS in Infrastructure Solutions US Air Force Academy Environmental Program

*Prepared by:
Tetra Tech EM, Inc.*

Floor Drain Cross-Connection Study

EXECUTIVE SUMMARY

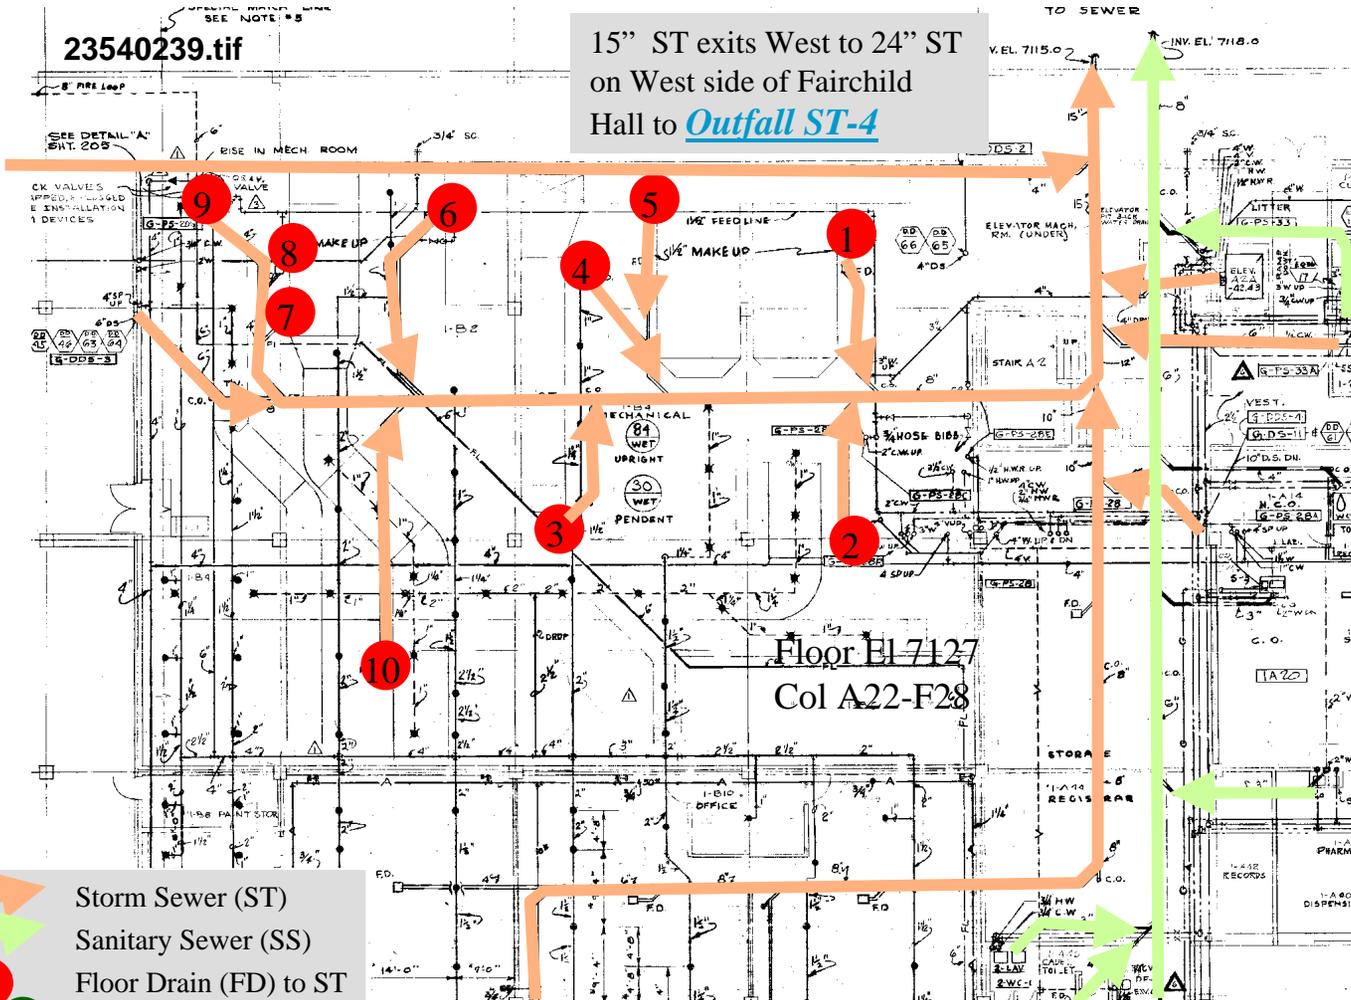
Fairchild 1B2

4" ST from mechanical room D2

15" ST exits West to 24" ST on West side of Fairchild Hall to Outfall ST-4

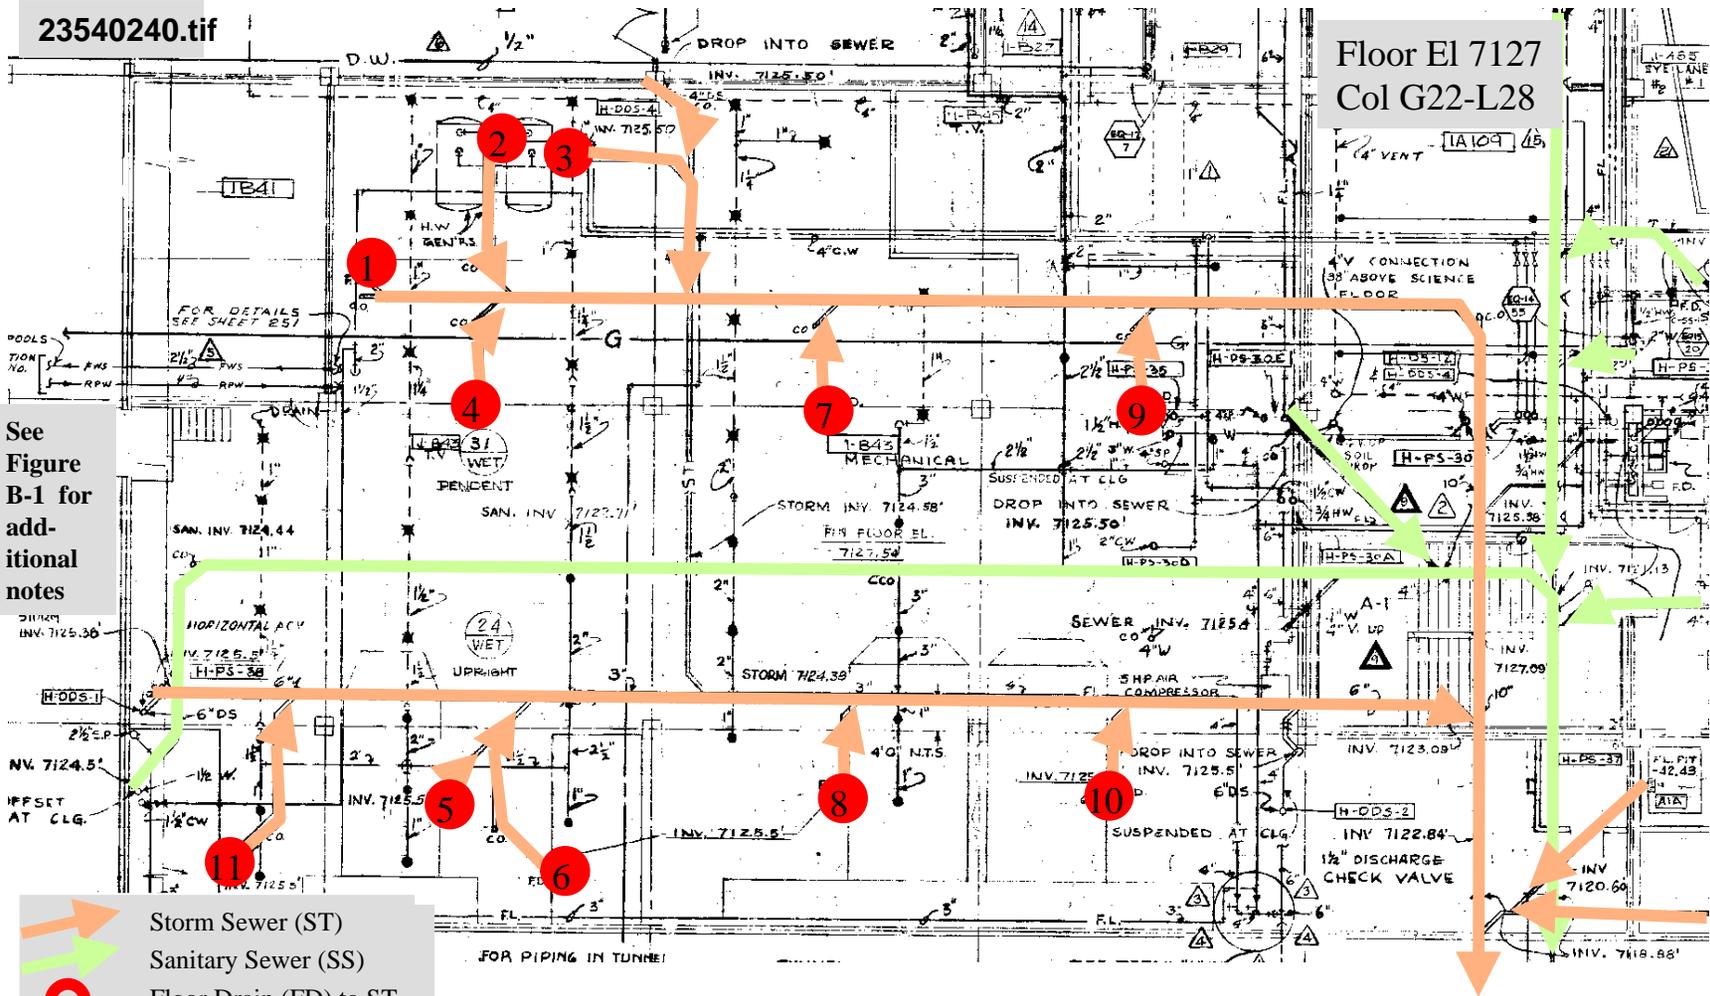
Fairchild 1B43

10" ST exits East to 24" ST on East side of Fairchild Hall to Outfall ST-4

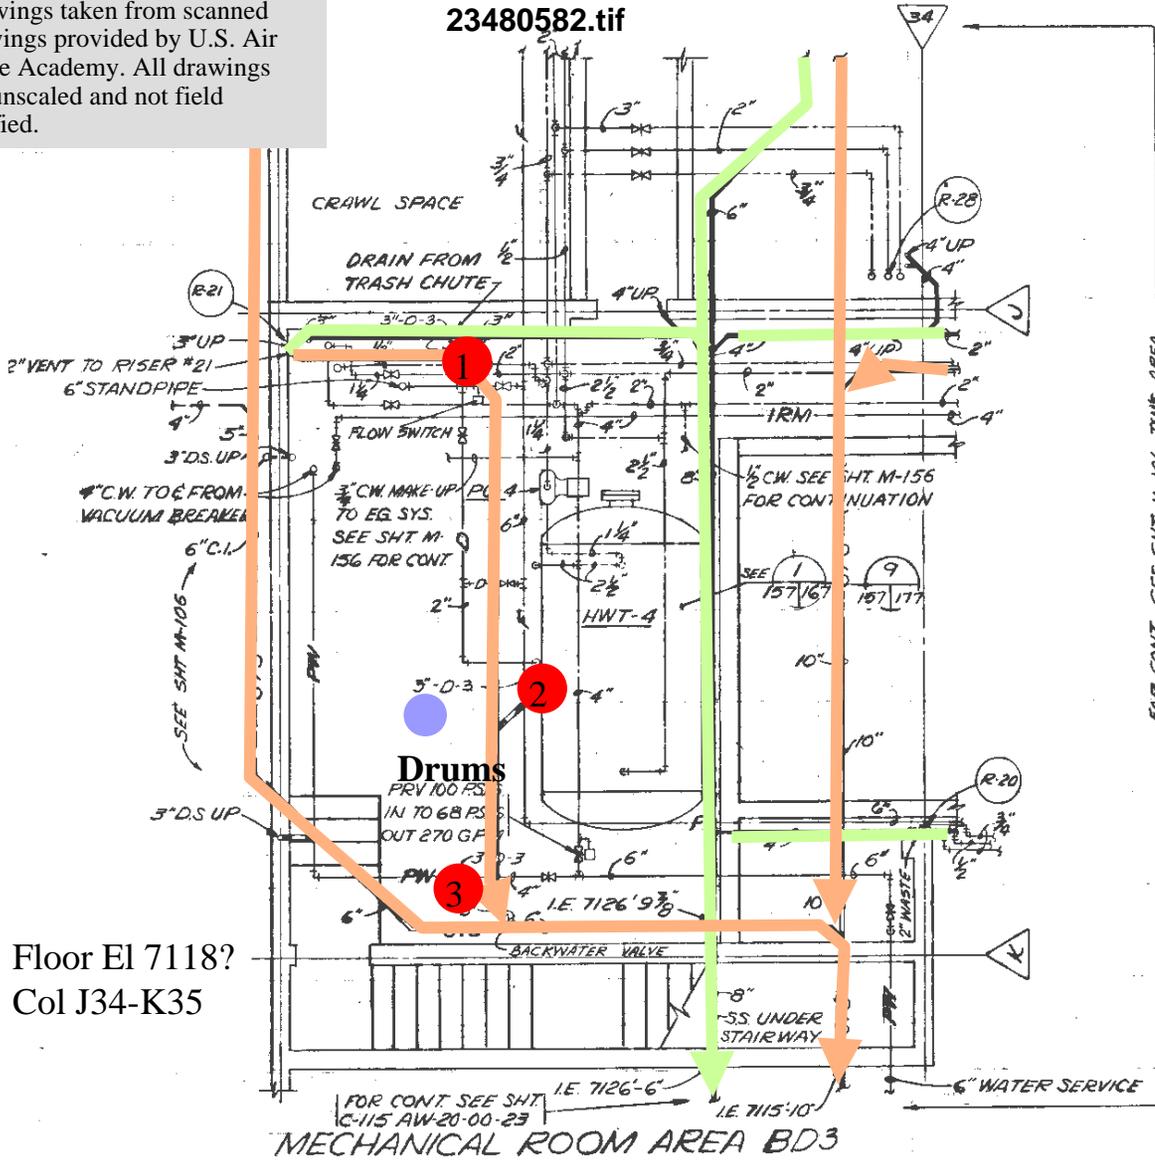
MECHANICAL ROOM AREA BD3

10" ST exits South to 21" ST on South side of Sijan Hall to [Outfall ST-1](#) Sijan BD3 (M)

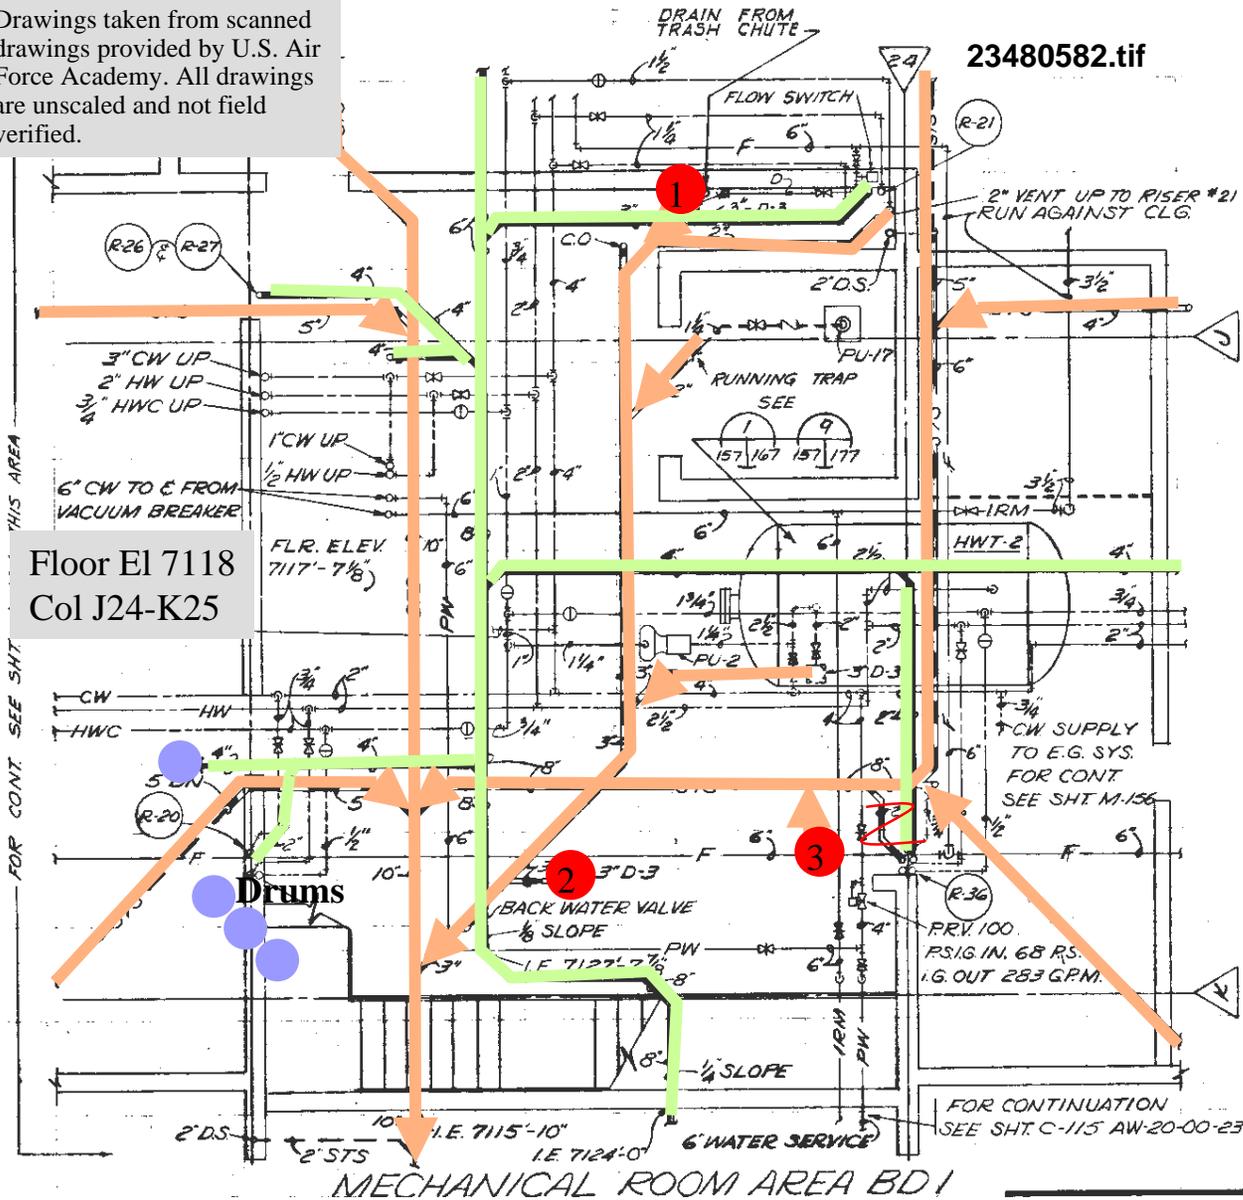
Sijan BD1 (K)

10" Storm exits South to 24" ST on South side of Sijan Hall to [Outfall ST-1](#)

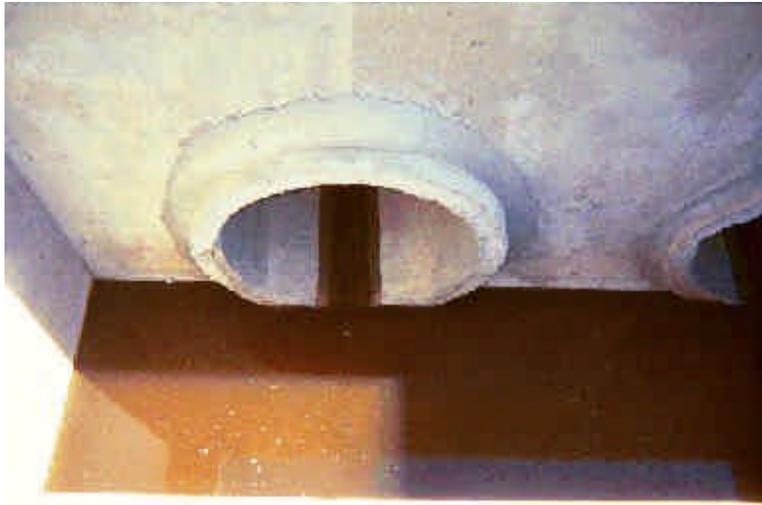
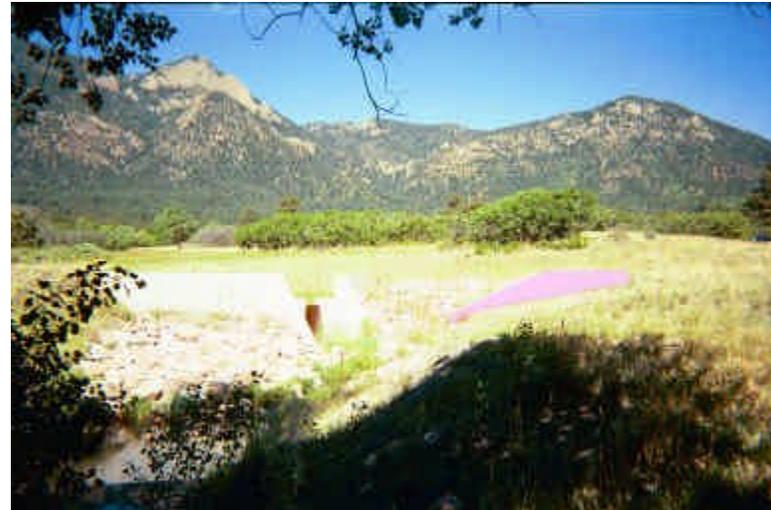
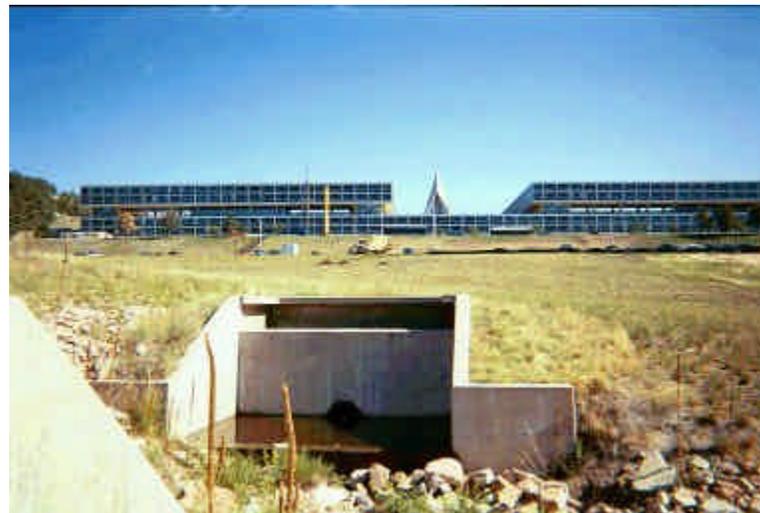
Outfall ST-1

Outfall looking North.

Outfall (highlighted in purple). Looking West.

Twin 42" Outfall located at
State Plane coordinates:
427,350 ± N
2,173,350 ± E
Colorado Central Zone

Outfall receives flow from the
Chapel and Sijan Hall (**BD1**
& **BD3**) and discharges
directly into Lehman Run.

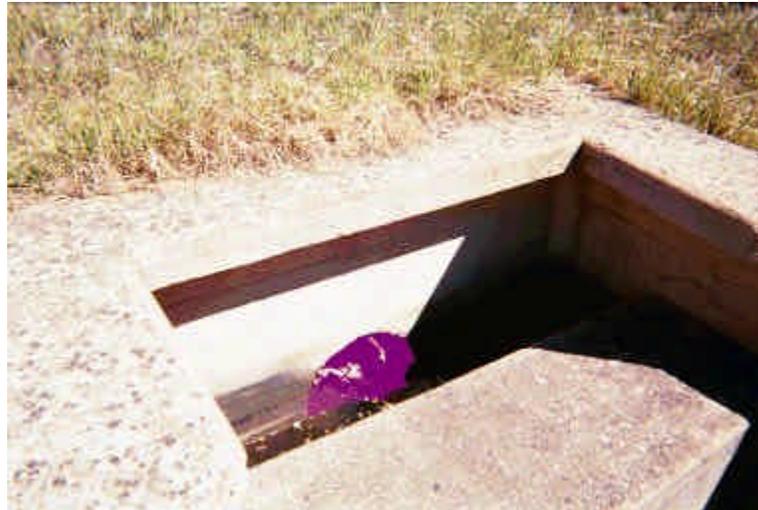
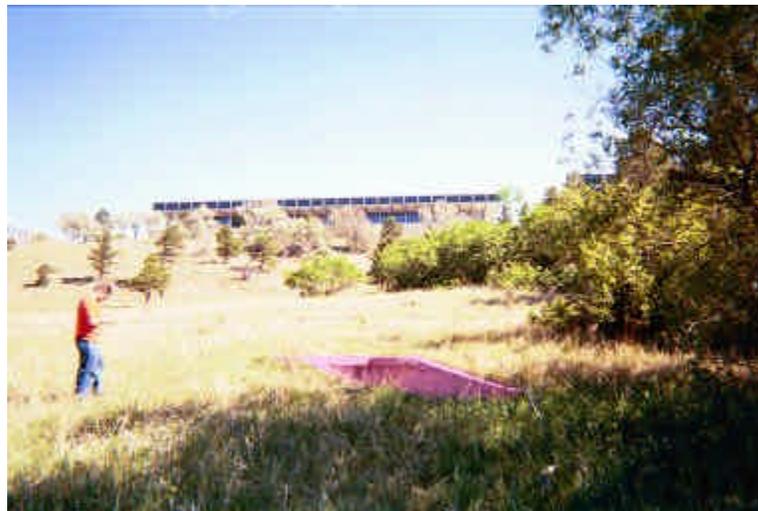
Outfall ST-4

Outfall (highlighted in purple). Looking Northwest.

**48" Outfall located at
State Plane coordinates:
427,120 ± N
2,174,470 ± E
Colorado Central Zone**

**Outfall receives flow from
Mitchell Hall (200, 404,
409) and Fairchild Hall
([1B2](#), [1B43](#), 1D2, 1E2,
1E9-S, 1E9-N, 1H2, 1H6,
1H7, 1H15) and
discharges directly into
Lehman Run.**

Outfall (highlighted in purple). Looking North.
