Ruptured Case in the M249 SAW

A Finite Element Analysis

Clinton Fischer

RDECOM-ARDEC

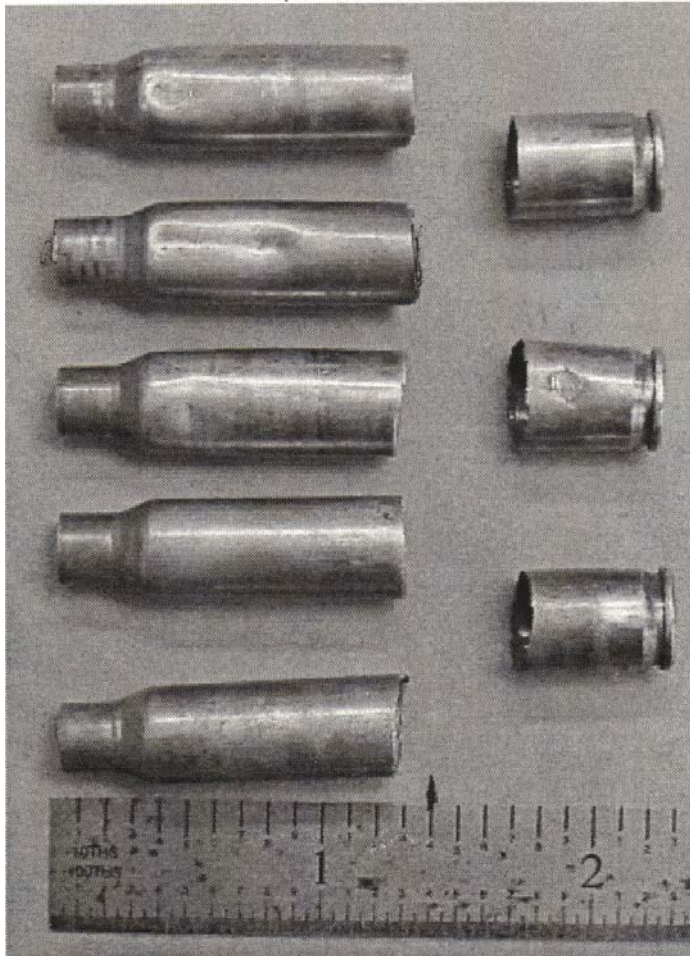
- Incidences of the M855 cartridge case rupturing during normal firing of the M249 Saw
- Cause was unable to be determined during live fire

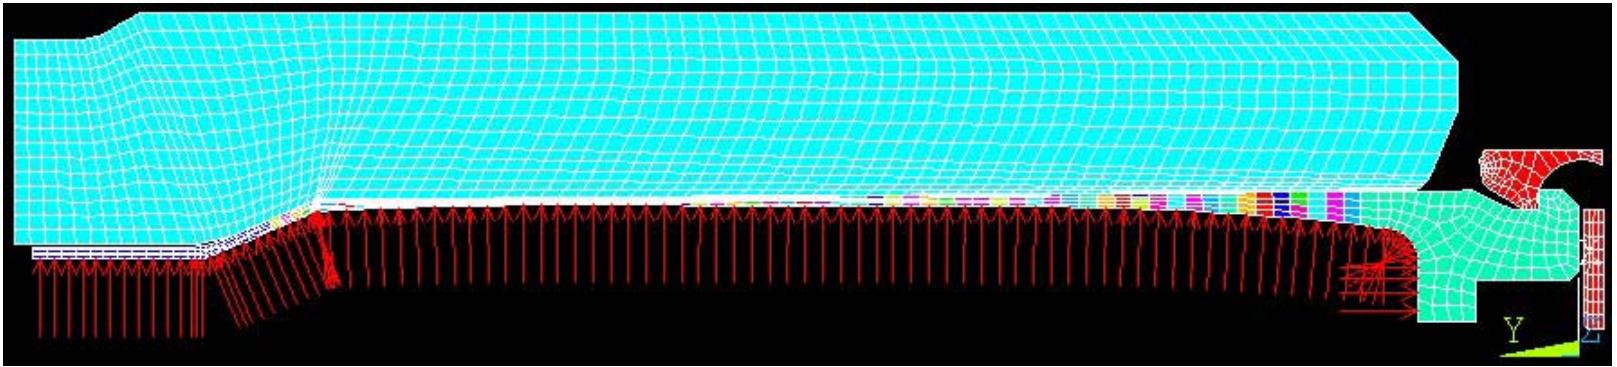
[Preliminary Modeling]

- Axi-symmetric Model
- Several scenarios were considered

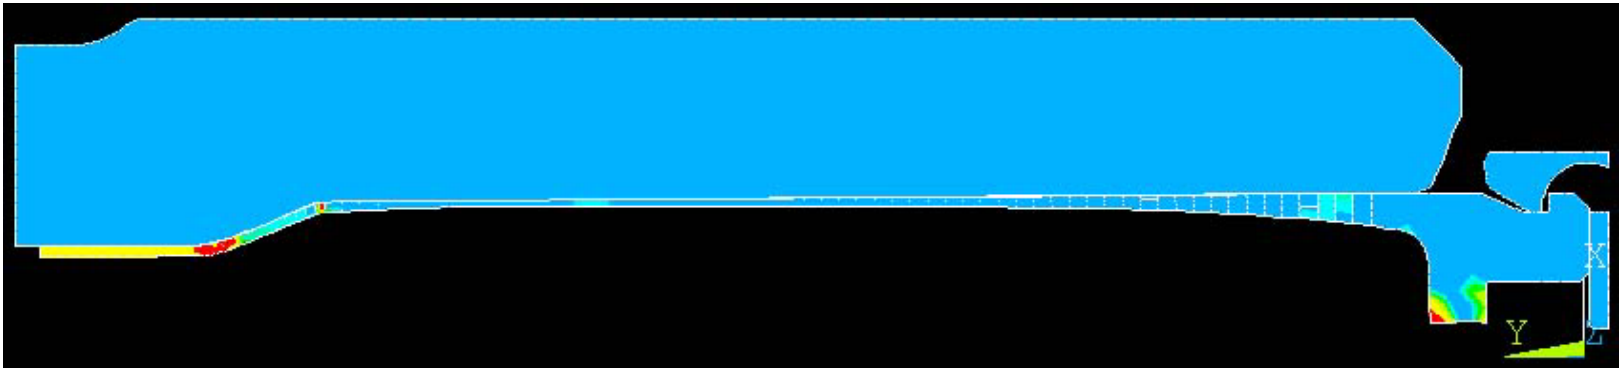
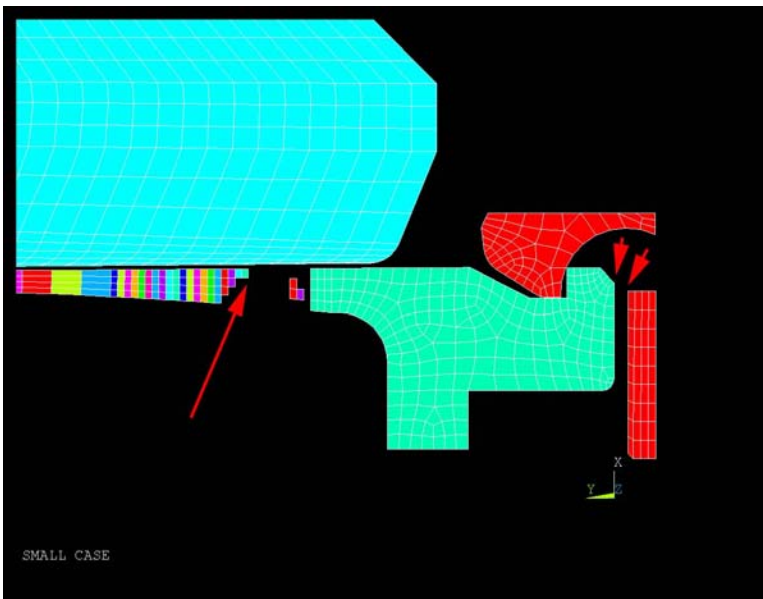
Observations

- No rupture in nominal case
- Longitudinal stretching causes rupturing
- All hardness gradients ruptured at same location and time

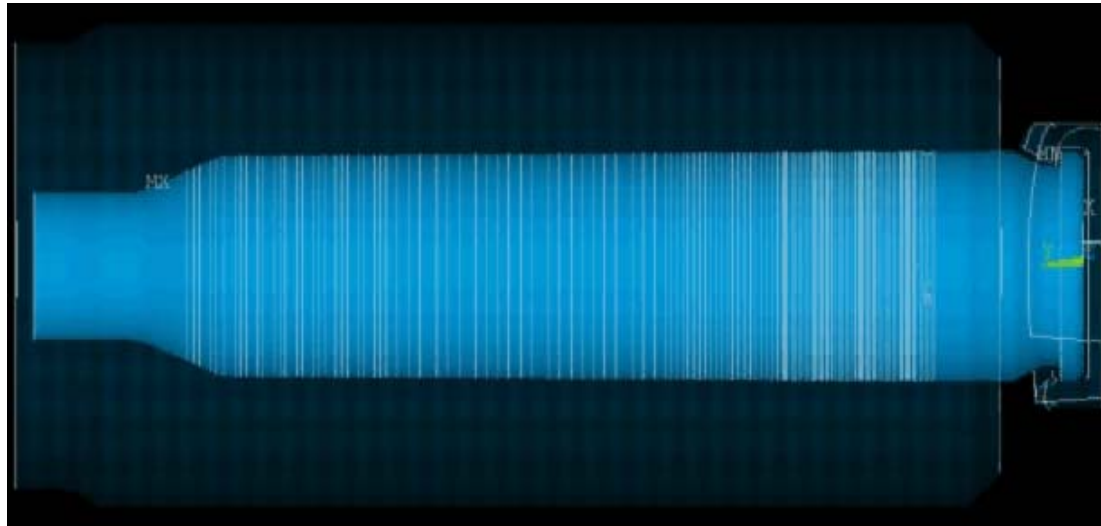
Secondary Results

- 3d Results corresponded to axi-symmetric models
- Brass material validated to 0.08% error
