US Army Corps of Engineers Engineer Research and Development Center Vicksburg, Mississippi

### 2005 Tri-Service Infrastructure Systems Conference & Exhibition August 1-4, 2005

### **Rubblization of Airfield Concrete Pavements**

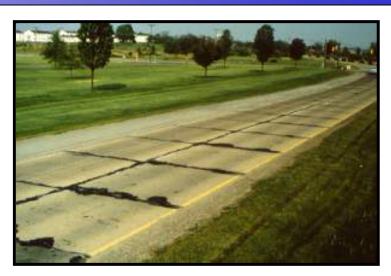
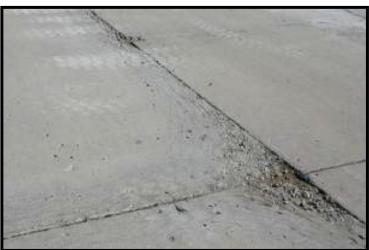
## Pavement Distresses

- Reflective Cracking
- Severe Joint Deterioration
- Slab Settlement
- Excessive Patching
- "Pop-outs", etc.

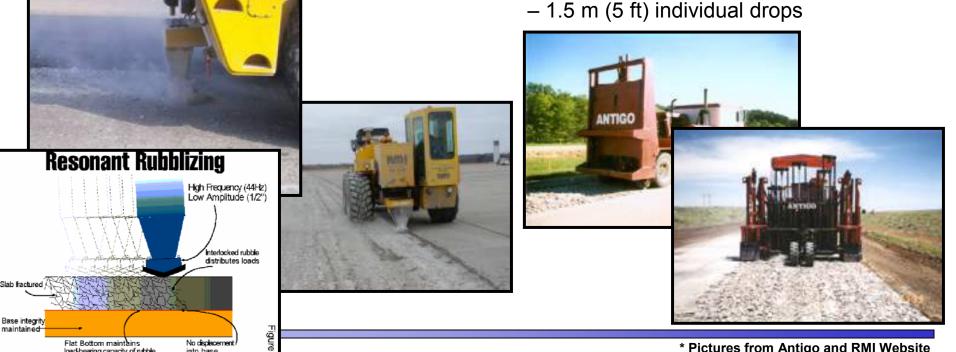
- Resonant Machines Inc. (RMI)
  - Resonant Breaker, RB-500
    - Low Amplitude
      - » 12 to 20 mm (1/2-3/4 in)
    - High Frequency Hammer
      - » 44-47 Hz

- Antigo Construction, Inc.
  - Guillotine Type Breaker
    - 5,440 kg (12,000 lb), 2.4 m (8 ft) hammer
  - Multi-Head Badger Breaker<sup>®</sup>
    - 16-450 kg (1,000 lb) hammers
    - 4 m (13 ft) wide

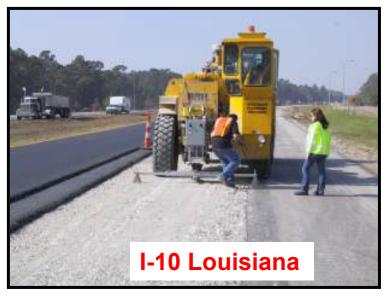
- I-10 Louisiana Rehabilitation Project
  - 11.0 km (7-mi) pavement rubblization
  - Contractor: Resonant Machines, Inc.
  - Pavement Structure:
    - 250 mm (10 in) AC O/L
    - 230 mm (9 in) Rubblized PCC
    - Subgrade: Sandy Soil

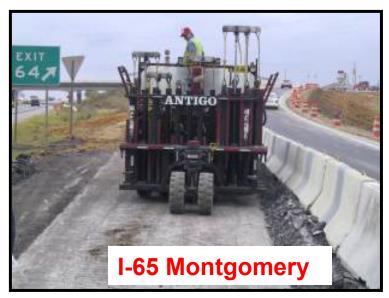
- I-65 Alabama Rehabilitation Project
  - Contractor: Antigo Construction, Inc.
  - Pavement Structure:
    - 280 mm (11 in) AC O/L
    - 250 mm (10 in) Rubblized PCC
    - Subgrade unknown
  - Test Pits required every 305 m (1000 ft)

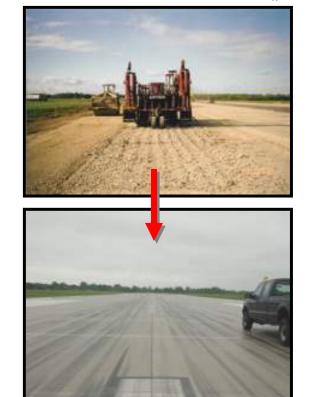
Selfridge ANG Base Rubblization Project

- Runway Reconstruction, Summer 2002
- Equipment (Antigo Construction Inc.):
  - Guillotine type breaker
  - Multi-Head Badger Breaker
- Pavement Structure
  - 180 mm (7 in) AC O/L
  - 115 mm (4.5 in) Crushed Concrete Base Course (leveling course)
  - Rubblized PCC thicknesses varied from 330 to 530 mm (13-21 in)
  - Subgrade: Silty Sand soils

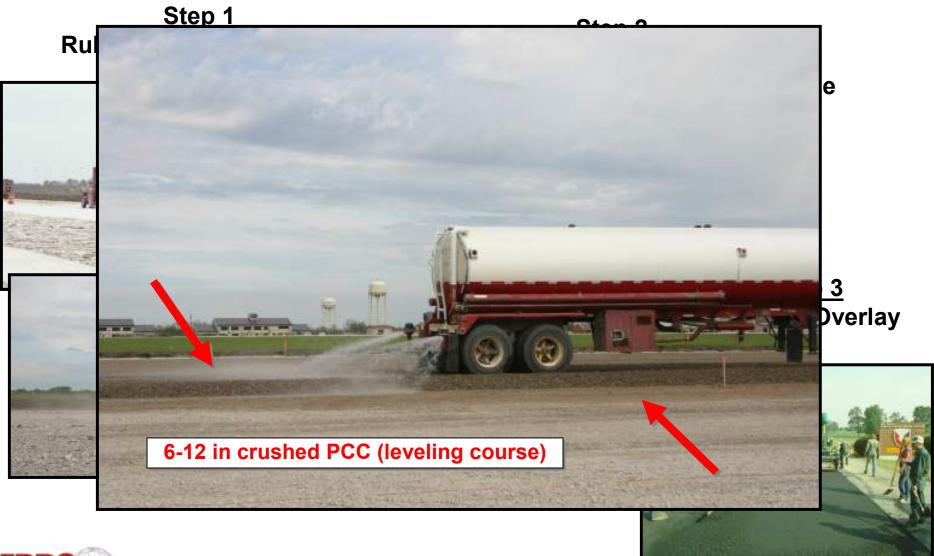
## Grand Forks AFB Rubblization Process

• GF AFB Phase I Runway Rubblization: 14-inch PCC pavement

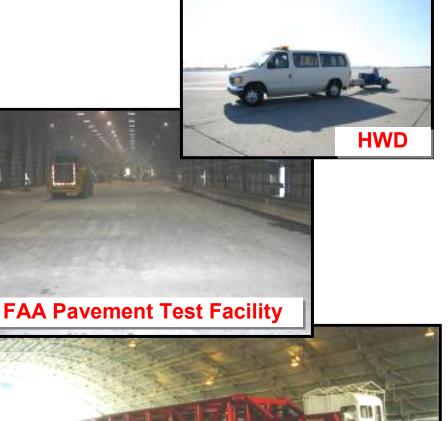
**HVS-A**

- FAA Pavement Test Facility, New Jersey
  - Load/Rolling tests
    - HVS
    - Aircraft loading
- Monitor Long-term Rubblization Projects
  - Existing condition evaluations
  - Non destructive testing:
    - HWD/FWD
  - Evaluate "old" crack & seat projects
    - Aberdeen Proving Grounds
  - Traffic responses
    - 5 (+) year term
    - HVS-A
      - Full-Scale Accelerated Pavement Testing
  - Other projects:
    - USAF Elimination of Alkali-silica Reaction (ASR)
    - Travis AFB, California
