Successful First AESA Deployment through Application of Systems Engineering

29 October 2009

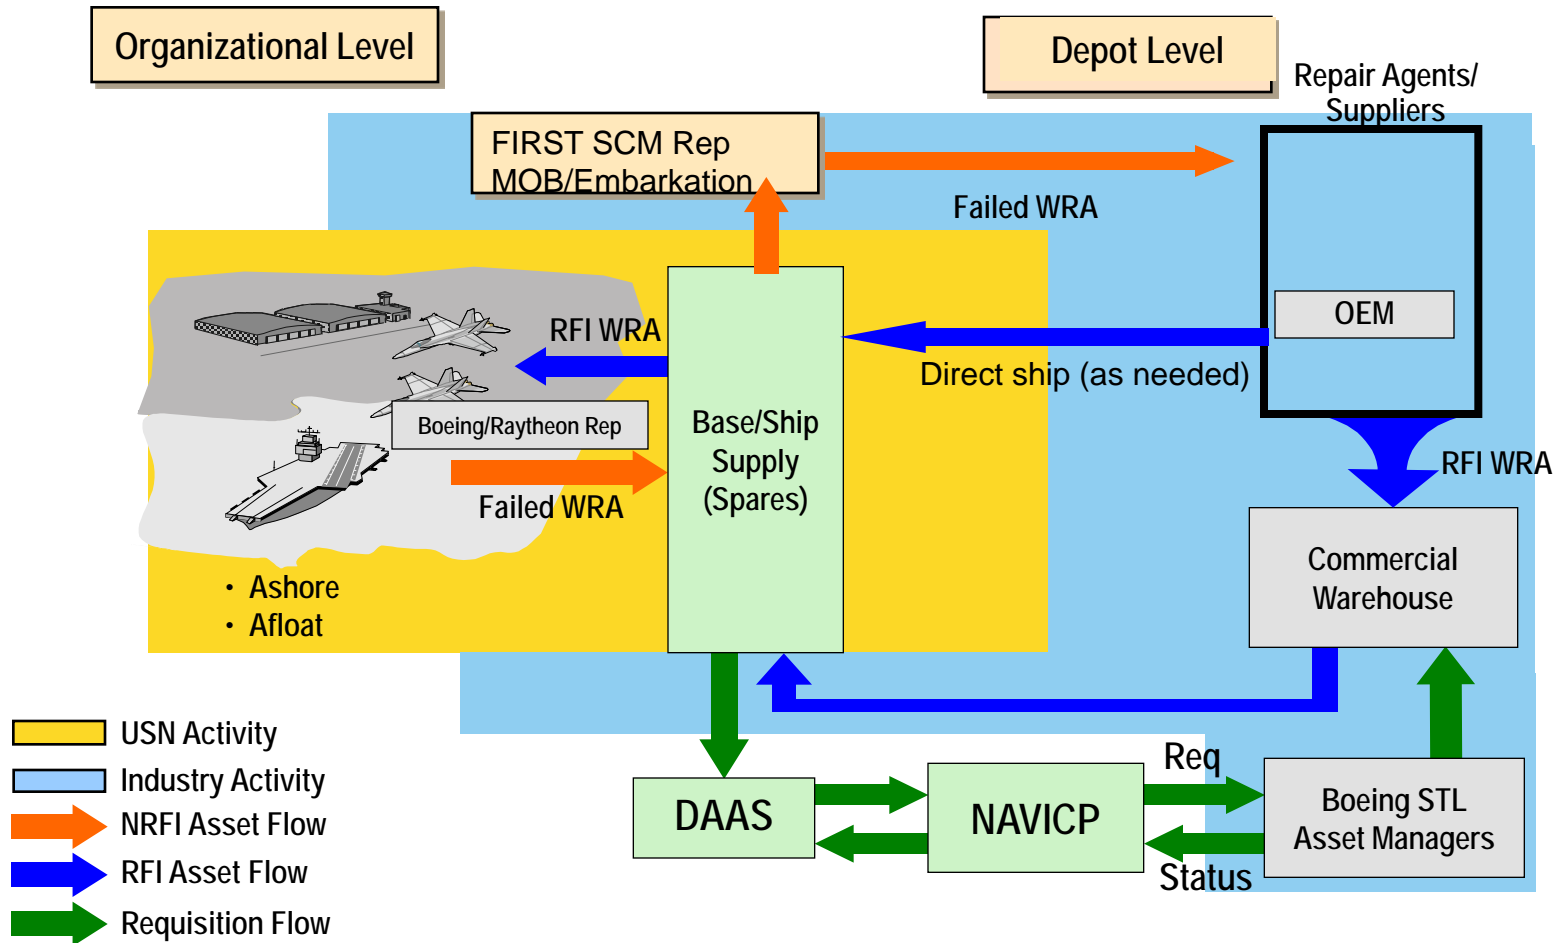
AESA Maintenance Concept

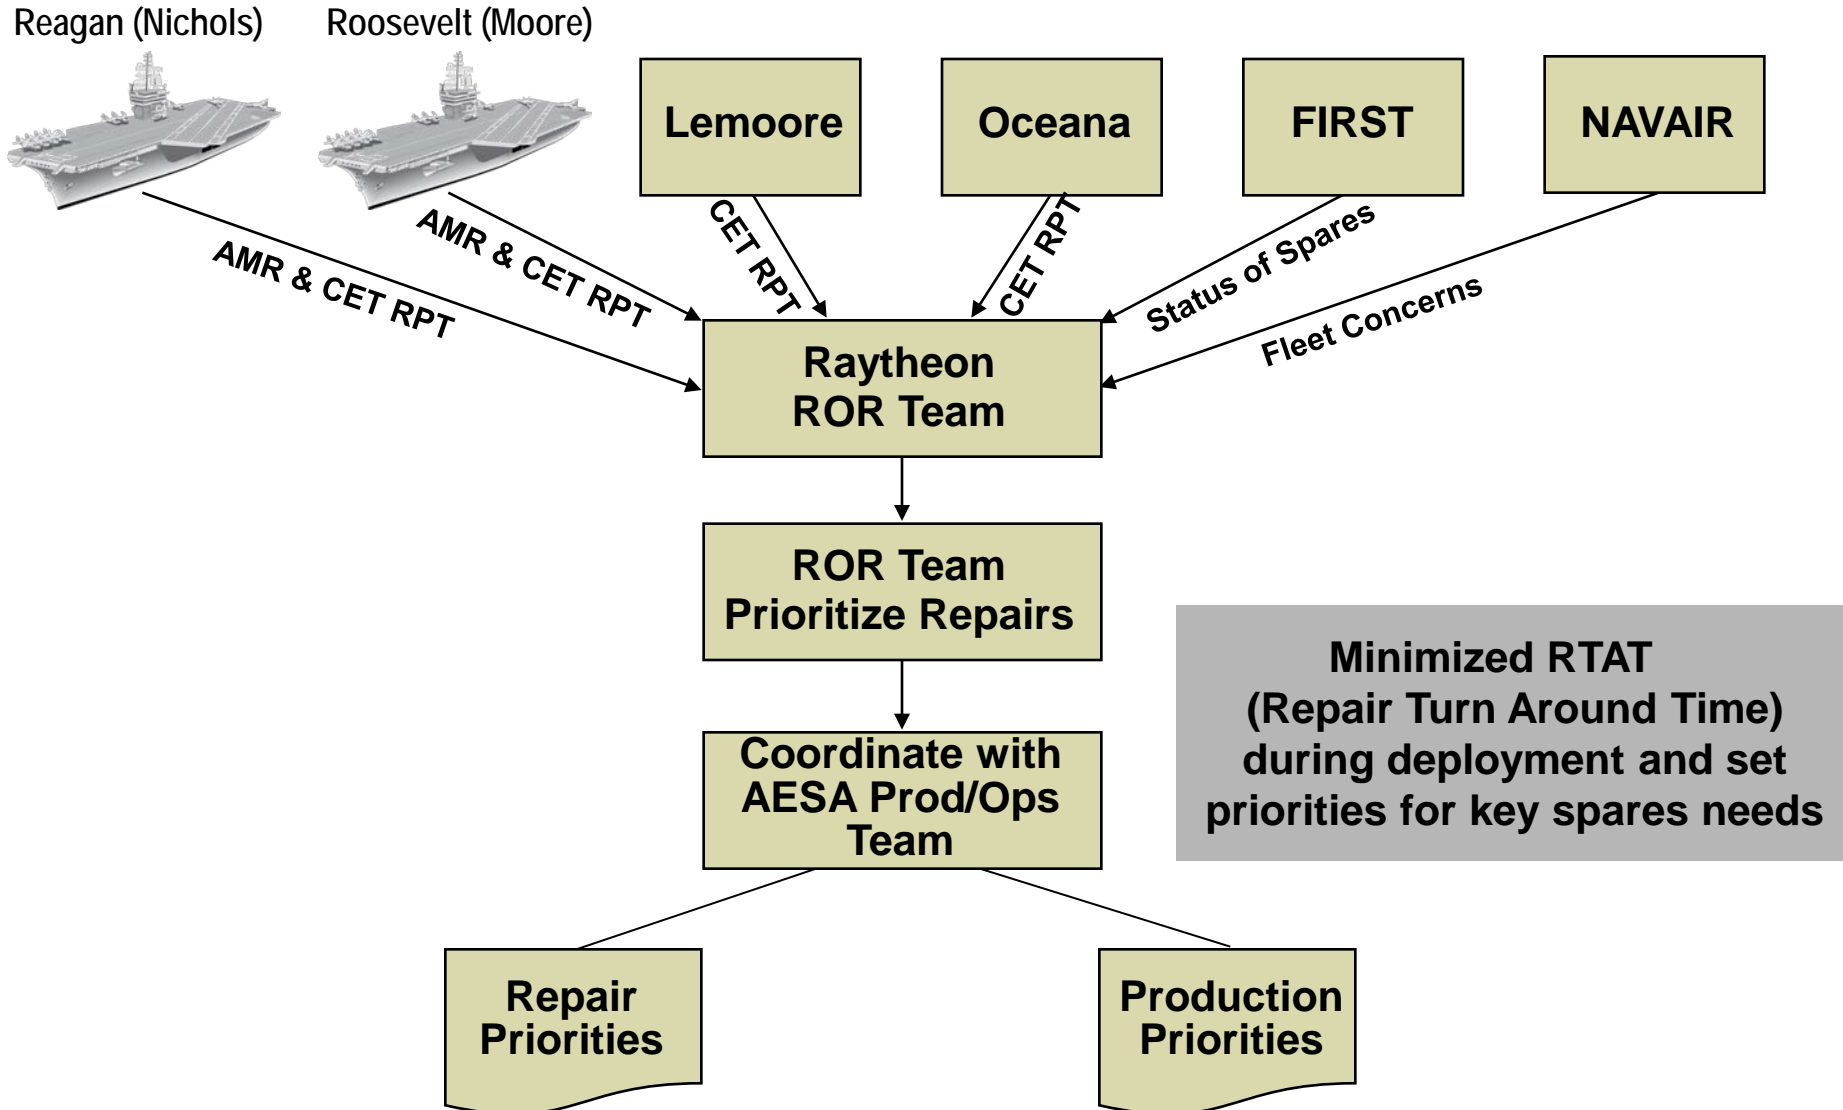
24 Hour Help Desk/Repair Communication Flow Process Implemented
