Test Method to Evaluate High-g Component Susceptibility

2018 NDIA Fuze Conference San Diego, CA

Daniel Peairs, Nathan Millard, Triet Dao, Marc Worthington L3 Defense Electronic Systems

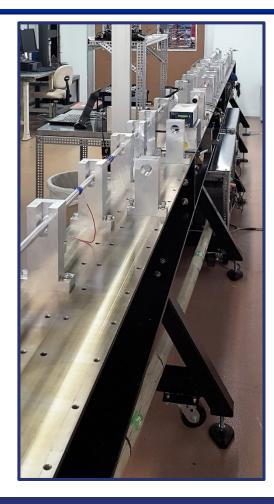
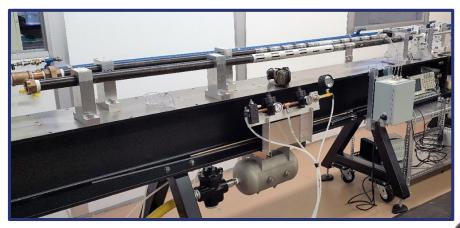
ESAD Electronics Characterization and Survivability

- Single Hopkinson Bar Testing
 - Conduct high acceleration/high frequency testing of select electronic components
- Modeling of components and FEA
 - Correlate high fidelity FEA models of components with empirical results
