KeyMod™ vs. M-LOK™ Modular Rail System Comparison

Abstract #19427

Presented By: Caleb McGee

Date: 4 May 2017

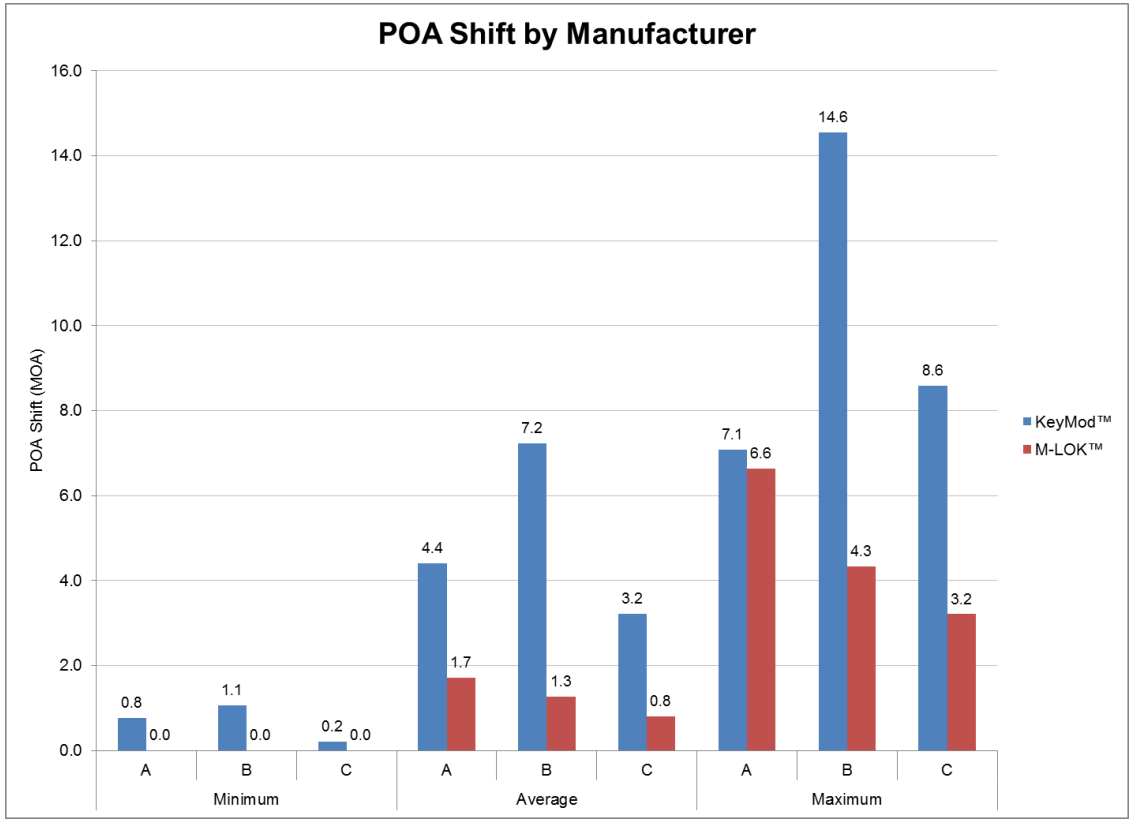
- KeyMod™ POA shift:
  - Absolute minimum: 0.2 MOA
  - Absolute maximum: 14.6 MOA
  - System average: 4.9 MOA
- M-LOK™ POA shift:
  - Absolute minimum: 0.0 MOA
  - Absolute maximum: 6.6 MOA
  - System average: 1.3 MOA

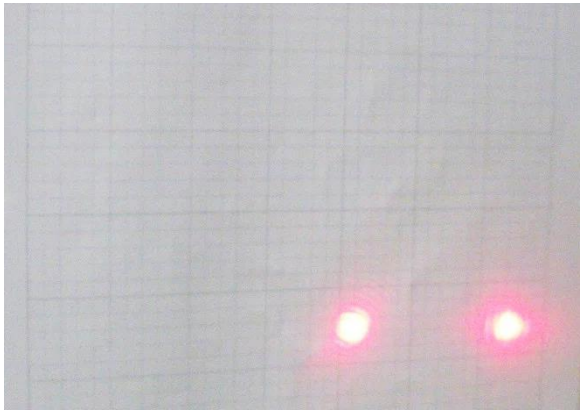
- M-LOK™ repeatability dependent on correct installation.
- Tested worst case repeatability incurred when M-LOK™ accessory is not properly installed per manufacturer instructions.
  - Installed M-LOK™ accessory rail per manufacture instructions and zeroed laser sight.
  - Removed and reinstalled accessory rail at maximum angle allowed within the M-LOK™ slot.
  - Improperly installed average POA shift: 18.4 MOA
  - Properly installed average POA shift: 1.3 MOA

Weapon ID	POA Shift (MOA)	
	Left	Right
A4	21.4	24.4
A5	20.3	19.7
A6	27.8	21.8
B4	19.3	19.3
B5	19.3	15.8
B6	17.1	17.5
C4	14.6	15.0
C5	13.3	12.8
C6	17.1	15.0

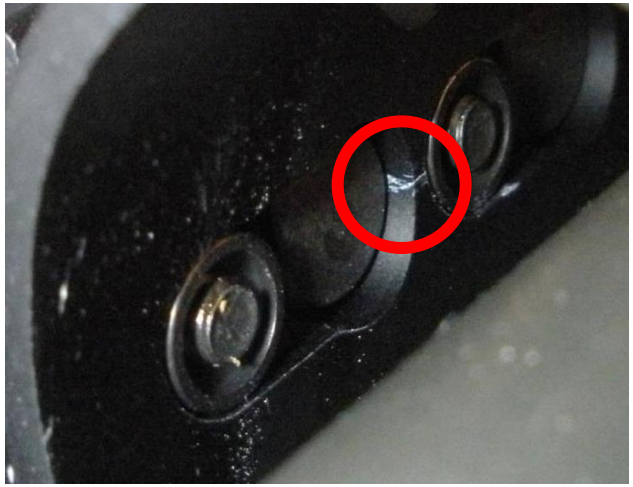
- Drop 1 – no damage.
- Drop 2 – scrape at 3 o'clock position on the handguard.
- Drop 3 – slight gap was between the handguard and receiver.
  – weapon light slid forward ~2 mm (~0.08 in) within the flashlight mount.
- Drop 4 – scraping on handguard.
- Drop 5 **– fracture between the KeyMod™ slots.**
- Drop 6 – major handguard damage around accessory rail.
  – accessory rail loosened but remained attached to the deformed handguard.

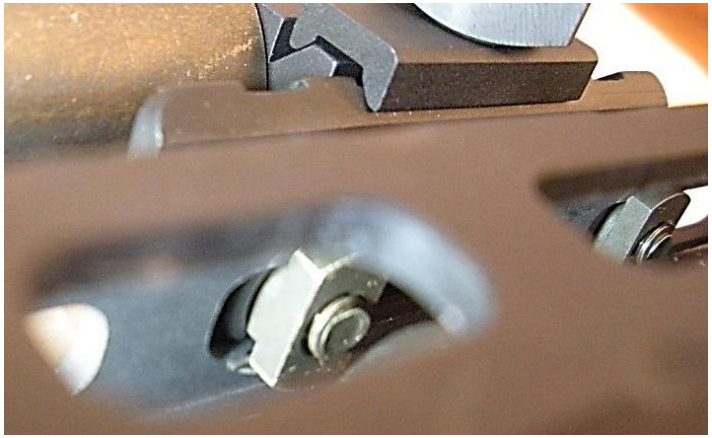
- Drop 1 – significant damage to 12 o'clock rail.
- Drop 2 – no new damage.
- Drop 3 – handguard displacement on barrel nut.
  – slight handguard rotation on barrel nut.
- Drop 4 – increased handguard displacement on barrel nut.
- Drop 5 – handguard rotation ~45° on barrel nut.
  – increased handguard displacement on barrel nut.
- Drop 6 – handguard pushed rearward onto barrel nut, damaging torque plate.
  – accessory rail remained in place with minimal movement.

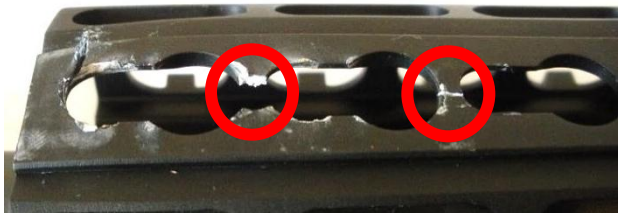
A1

- KeyMod™ Damage:
  - Complete separation of accessory rail from handguard.
  - Fracture between the two KeyMod™ slots utilized.
  - Fracture between utilized KeyMod™ slot and an adjacent slot.
  - No major damage to KeyMod™ fasteners.
  - Front of KeyMod™ slots damaged where fasteners were mounted.
  - No removed material captured between accessory rail and mounting nut.

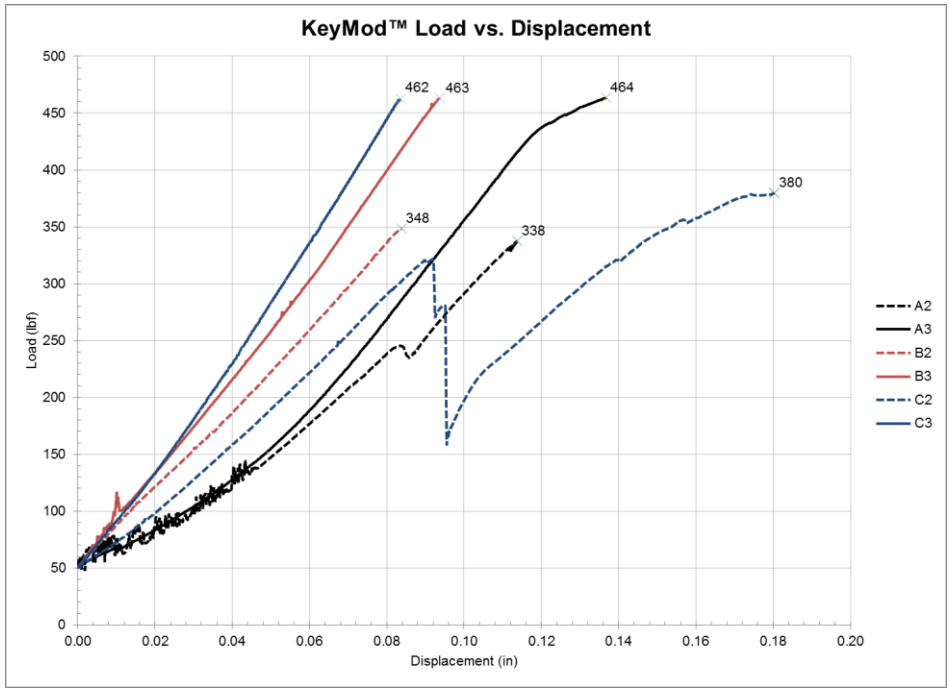
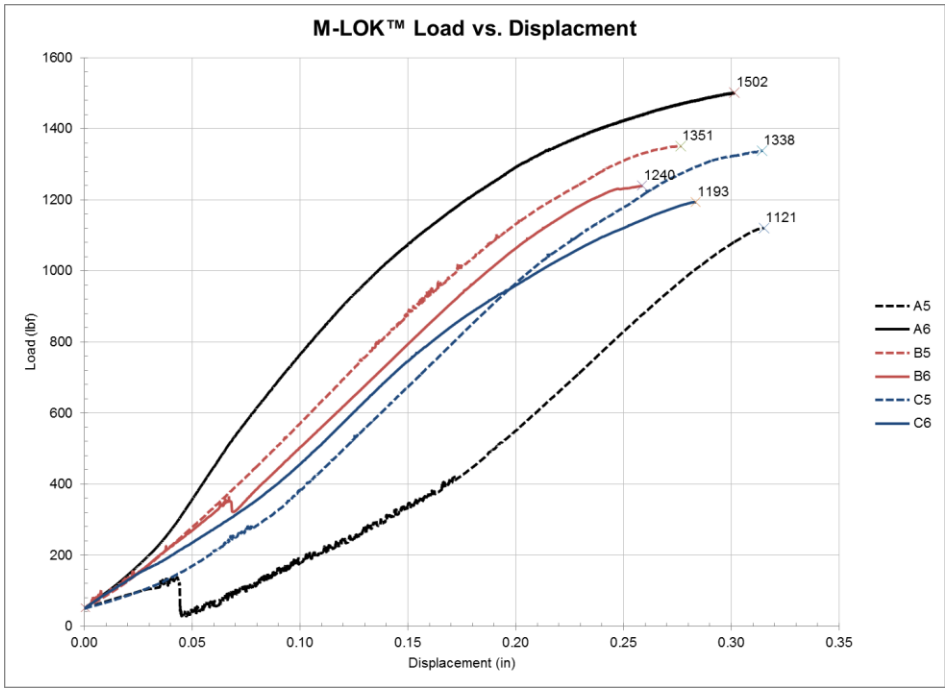
- KeyMod™ system loading shows mostly linear, elastic properties.
- M-LOK™ system loading shows non-linear properties, especially at high loads.
- Some momentary load drops from fixture slipping.

- KeyMod™ systems showed nearly identical failure mode to that observed in drop testing.
  - Complete separation of accessory rail from handguard.
  - Fracture between the two KeyMod™ slots utilized.
  - Fracture between utilized KeyMod™ slot and an adjacent slot.
  - No major damage to KeyMod™ fasteners.
  - Front of KeyMod™ slots damaged where fasteners were mounted.
  - No removed material captured between accessory rail and mounting nut.

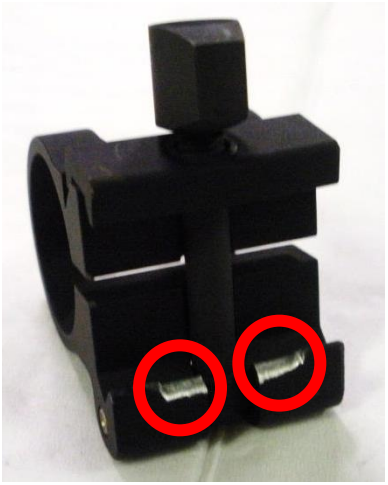
- All M-LOK™ tests featured failure modes at the weapon light mount.
  - 1/6 samples: mount fractured near clamping end.
  - 5/6 samples: mount pulled off of the deformed accessory rail.
- Increase of 215% in average sustained load of M-LOK™ over KeyMod™.
- M-LOK™ system tests showed 140-220% increase in sustained load over the maximum KeyMod™ load observed.
