Benefits of GIS in Infrastructure Solutions US Air Force Academy Environmental Program

*Prepared by:
Tetra Tech EM, Inc.*

Floor Drain Cross-Connection Study

EXECUTIVE SUMMARY

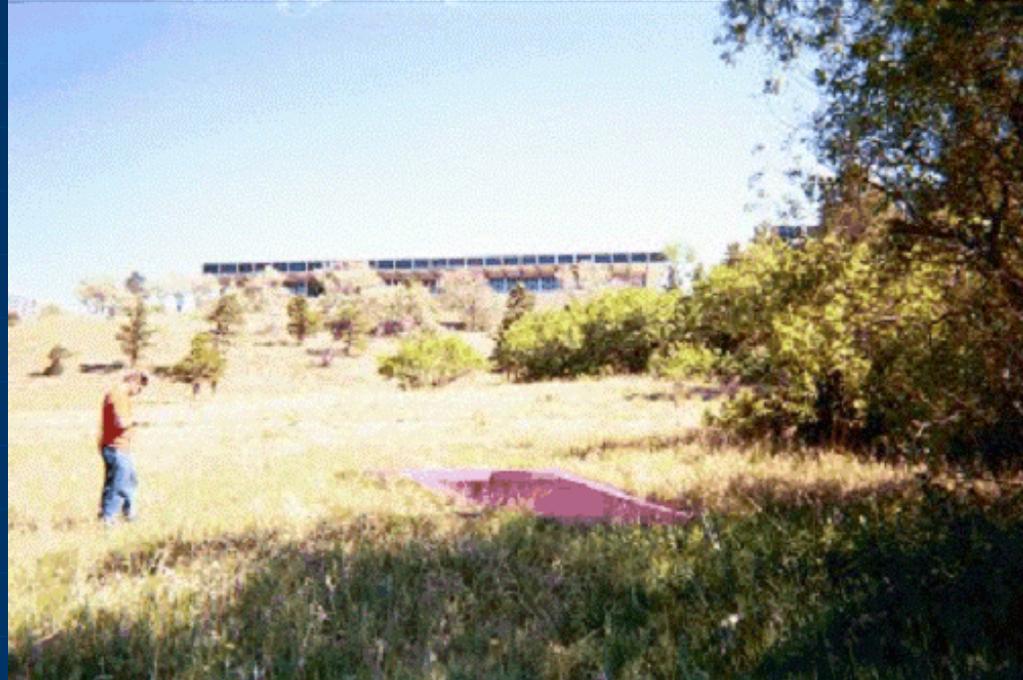
Spill 1: August 2001 Leak

- ◆ PG-contaminated water leaked for 4 days
- ◆ Approximately 10,000 gallons of contaminated water released
- ◆ At a 20% concentration, that equals approximately 2,000 gallons of PG

- ◆ Floor drains in the room were connected to the storm sewer system
- ◆ PG was released untreated into Lehman Run
- ◆ PG collected in three ponds on the Eisenhower Golf Course

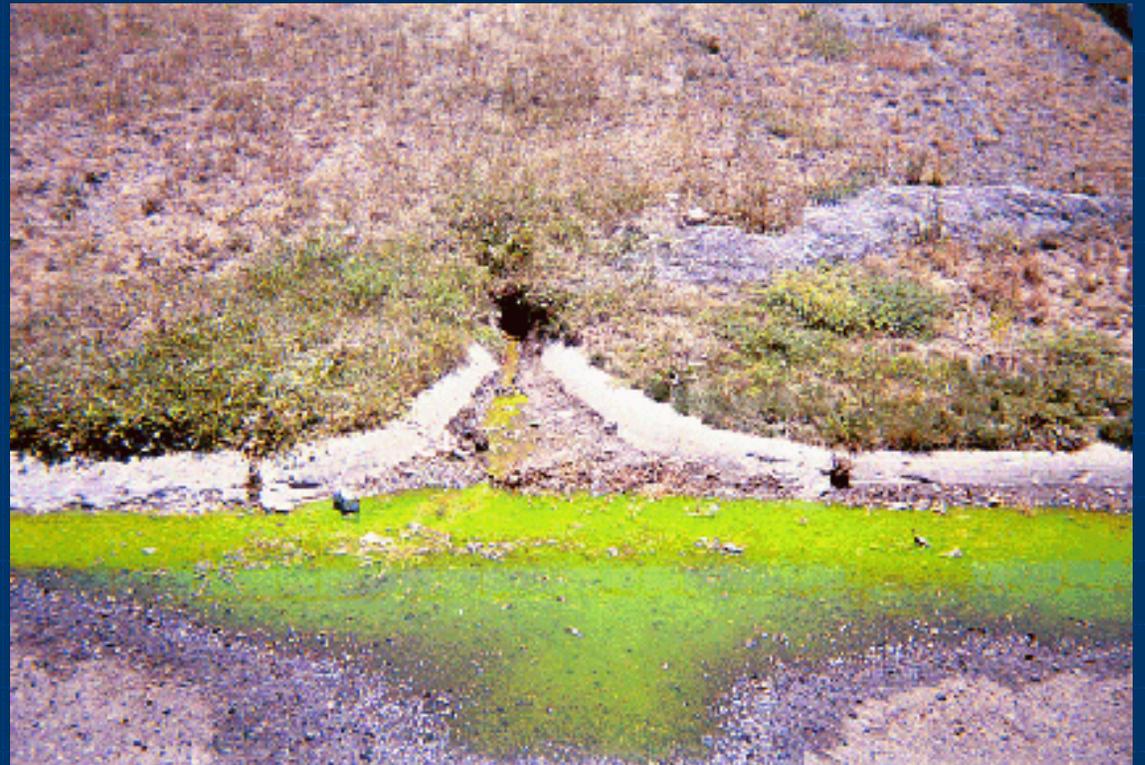
Step 5: Dye-testing

- ◆ Verify the accuracy of GIS and design drawings
- ◆ Determine floor drain connections for mechanical rooms where drawings were not available
- ◆ Determine floor drain connections for mechanical rooms that had been renovated since the original drawings were produced

- ◆ 43 (73%) mechanical rooms were dye-tested
- ◆ 30 (51%) Cadet Area mechanical rooms have floor drains connected to storm sewers
- ◆ All require corrective action

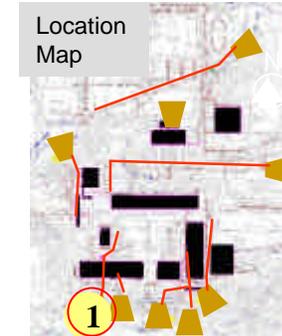
E-1

Twin 42" Outfall located at
State Plane coordinates:
427,350 ± N
2,173,350 ± E
Colorado Central Zone

Outfall receives flow from the
Chapel and Sijan Hall (**BD1**
& **BD3**) and discharges
directly into Lehman Run.

Outfall ST-1

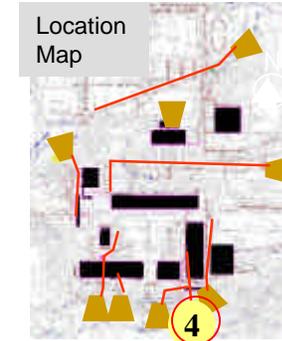
E-4

**48" Outfall located at
State Plane coordinates:
427,120 ± N
2,174,470 ± E
Colorado Central Zone**

**Outfall receives flow from
Mitchell Hall (200, 404,
409) and Fairchild Hall
([1B2](#), [1B43](#), 1D2, 1E2,
1E9-S, 1E9-N, 1H2, 1H6,
1H7, 1H15) and
discharges directly into
Lehman Run.**

Outfall ST-4
