## **COMPOSITE CUT-OFFS FOR DAMS**

## Dr. Donald A. Bruce, C.Eng. and Trent L. Dreese, P.E.

- 1. Alternative Definitions of "Composite" Cut-Offs
- Review of Individual Technologies
   2.1 Concrete Cut-Offs
   2.2 Drilled and Grouted Cut-Offs
- 3. Illustrative Case Histories
- 4. Observations and Conclusions

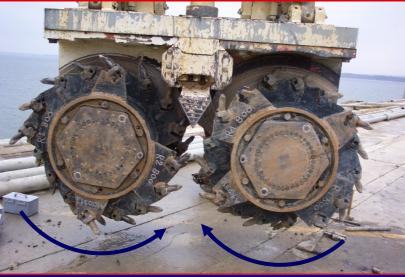
### **Panel Excavation**

The cutters continuously remove the soil from the bottom of the trench, breaks it up and mixes it with a bentonite slurry in the trench.

The slurry charged with soil particles is pumped through a pipe to the de-sanding plant where it is cleaned and returned into the trench.

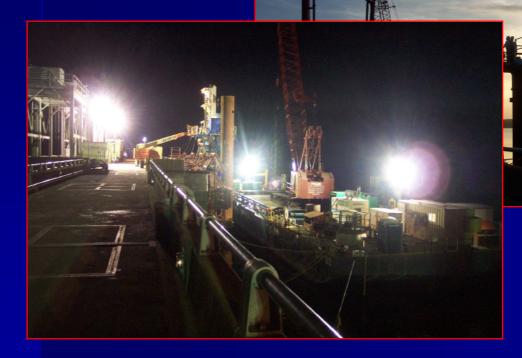
## 2. Review of Individual Cut-Off Technologies – Secant Pile Wall Technique

Drilling Around the Clock

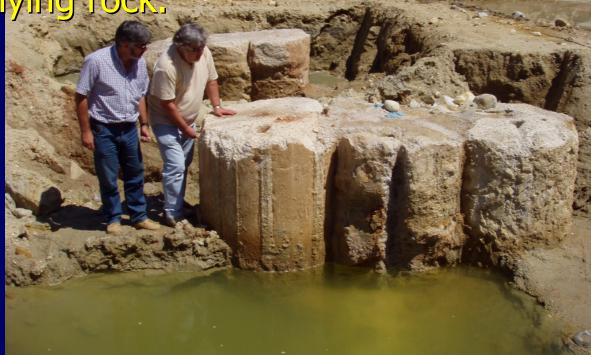
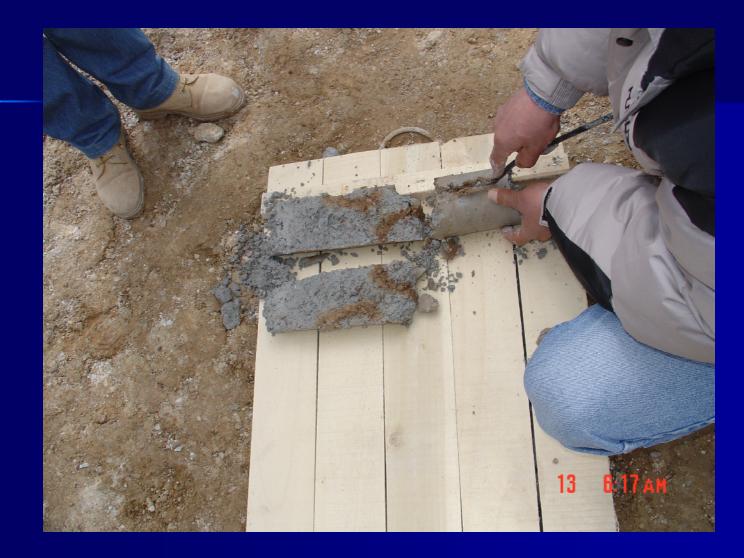
## 1. Papadia Dam, Greece

Plastic concrete cut-off in alluvium, grouting in underlying rock.

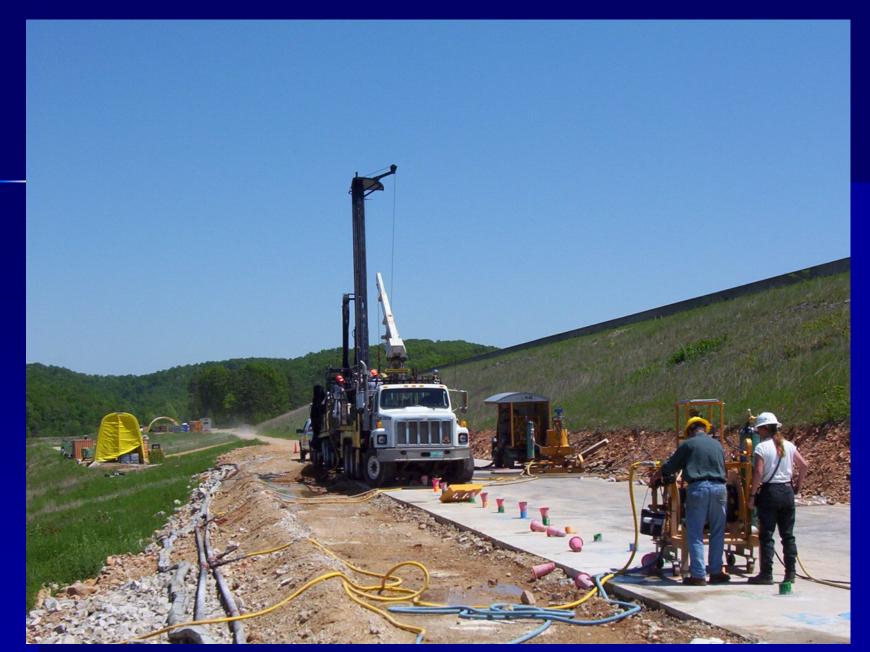
# 4. Clearwater Dam, Missouri

Localized drilling and grouting program for suspected major sinkhole locations, followed by more intensive program of drilling and grouting to optimize design (depth and length) of foreseen concrete cut-off.

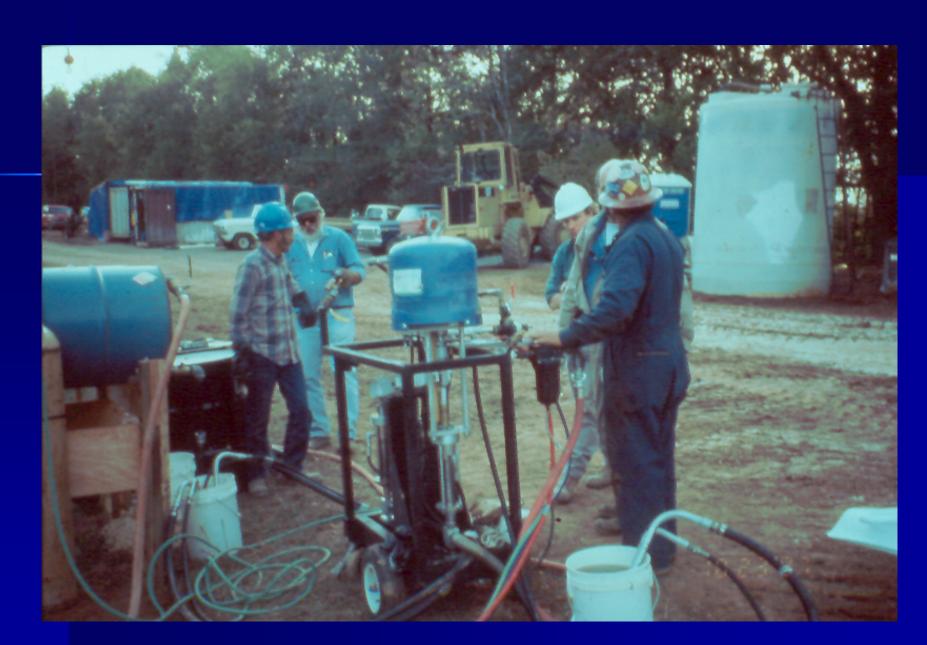
# 5. Tims Ford Dam, TN

# Remedial grout curtain in karst employing three families of grout materials – HMG, Polyurethane, LMG.

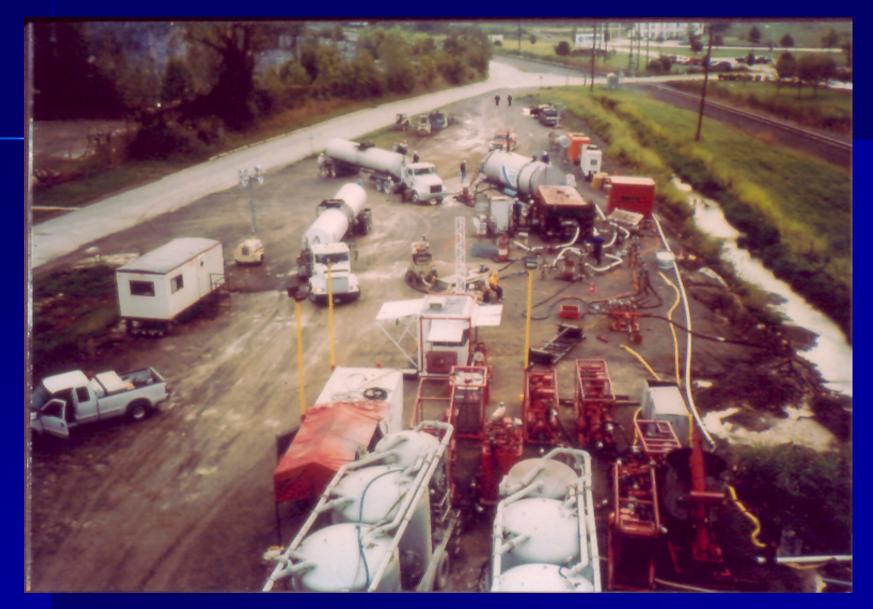
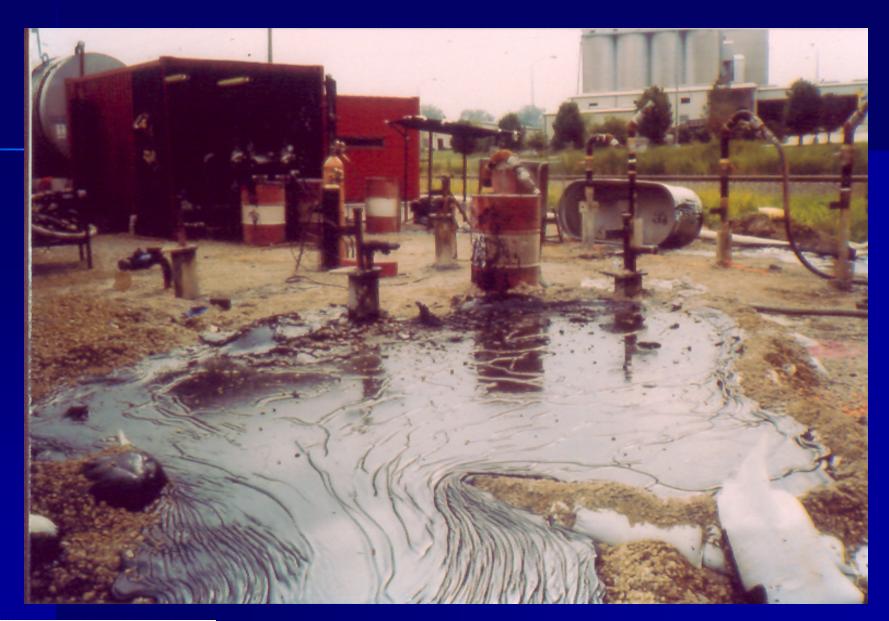
# 6. Limestone Quarry, Cape Girardeau, MO

Grout curtain created to stop 30,000 gpm flow through karst into quarry using three families of grout – HMG, LMG and Hot Bitumen.

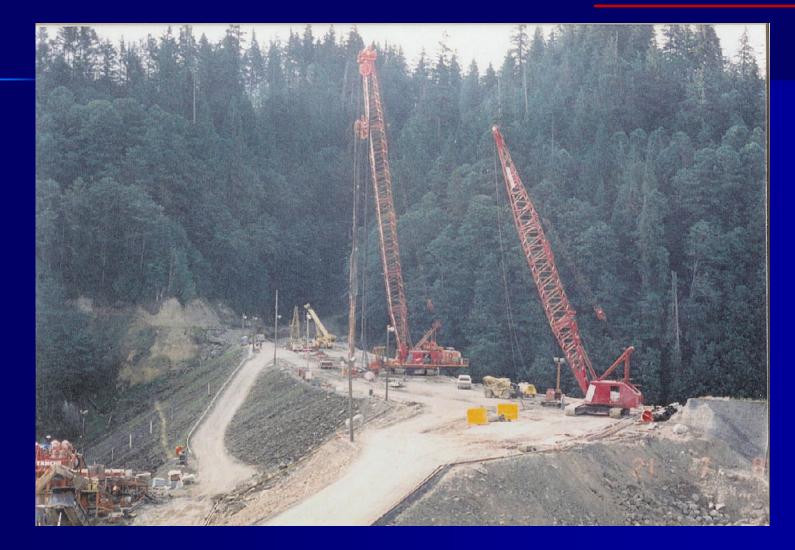
#### MUD MOUNTAIN

# 7. Mud Mountain Dam, WA

Treatment by grouting of fissured clay core to permit diaphragm wall to be built without catastrophic loss of slurry.

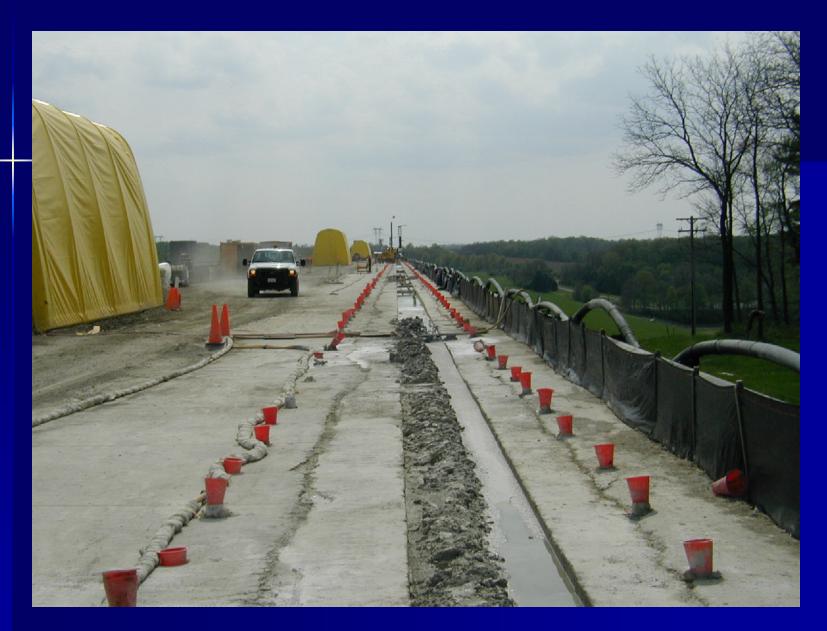
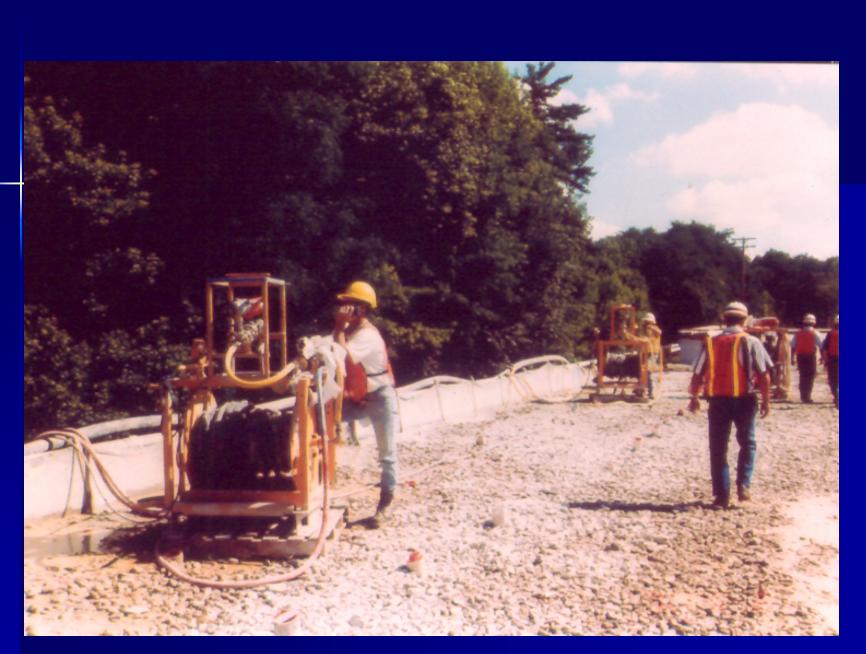
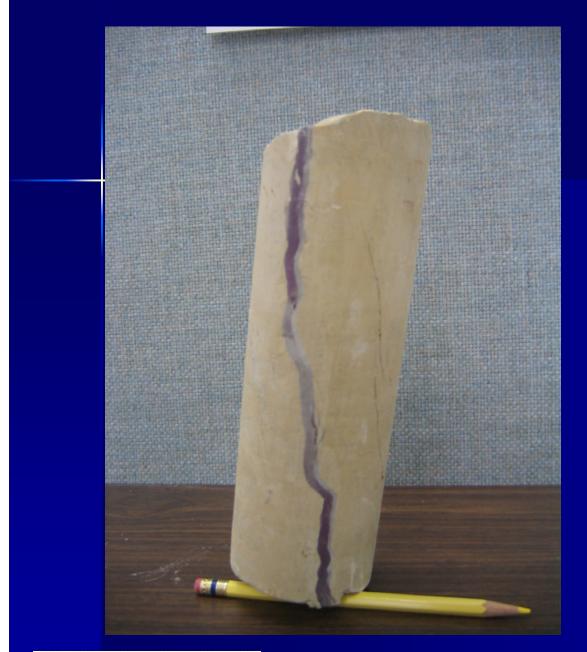
# 8. Mississenewa Dam, IN

Treatment by rock and void grouting techniques of karstic bedrock to permit diaphragm wall to be built without catastrophic slurry loss.

Clear example of equivalent performance of grouting to concrete cut-off wall construction.

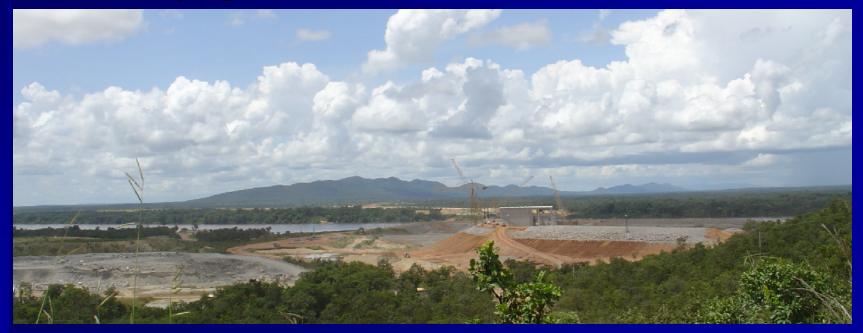
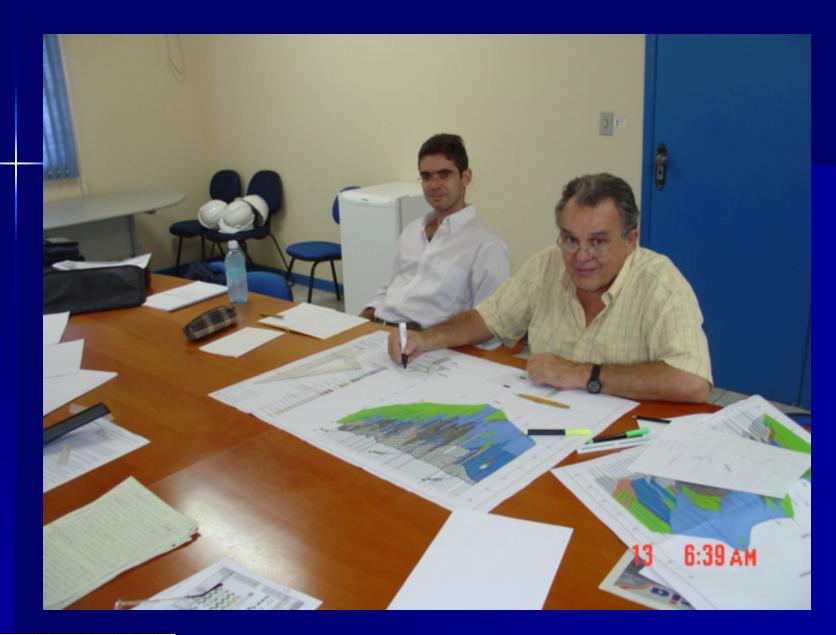
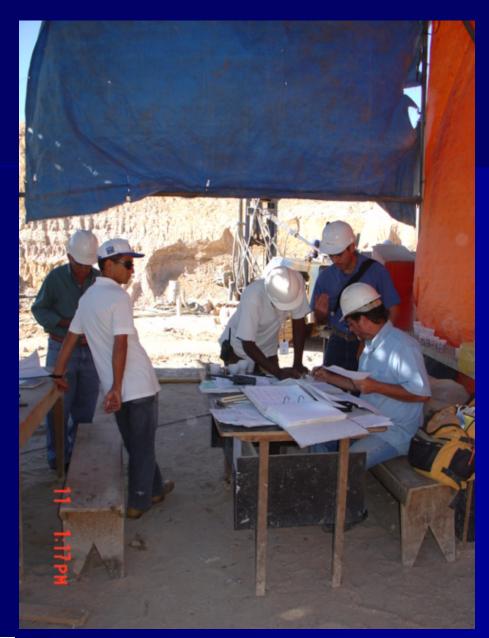
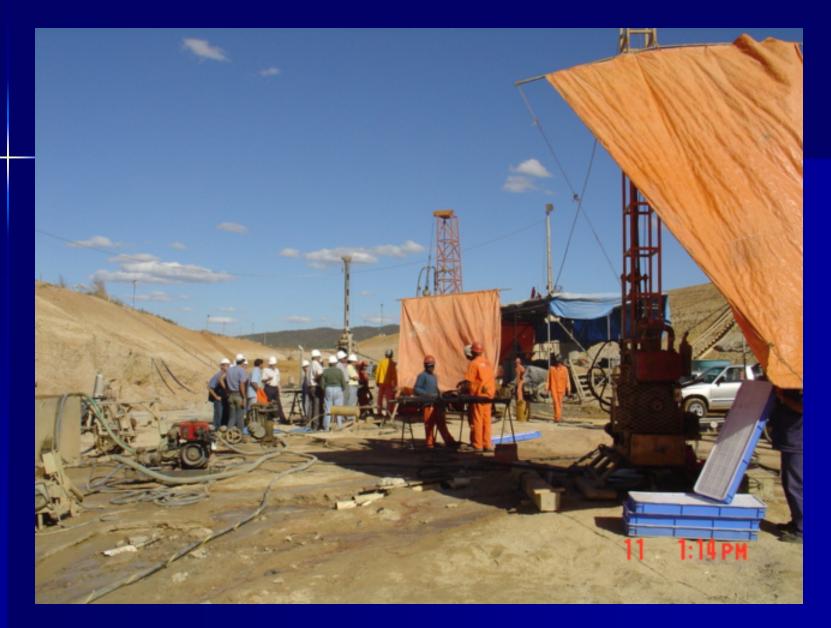
# 9. Peixe Dam, Brazil

Rock grouting used in voided/fissured karstic limestone inlier. Jet grouting required to treat weathered, soil-like materials lying above fresher rock.
