Joint Service Power Expo 2011

**Battery Management
and Sustainment System**

Presented by:
PulseTech Products Corporation
Mark Abelson
800-580-7554, ext. 167
817-307-5603 (cell)
mabelson@pulsetech.net
www.pulsetech.net

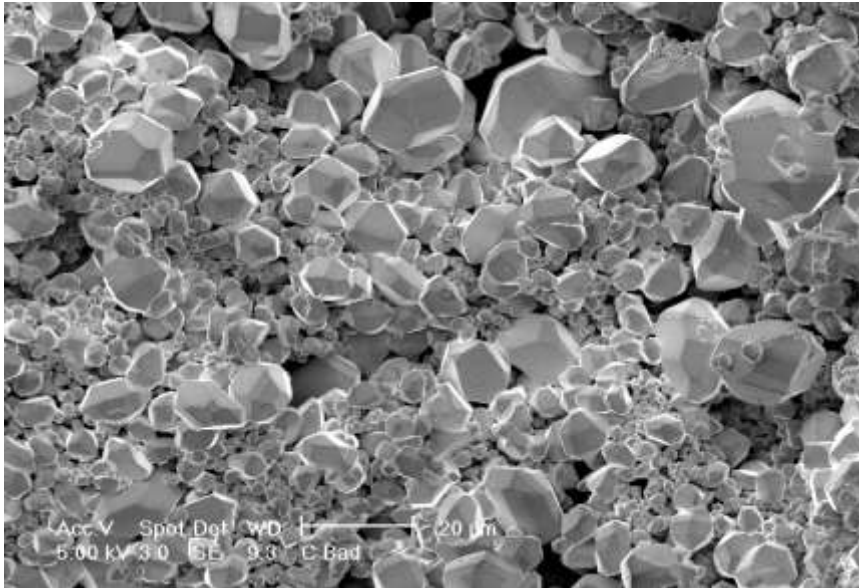
Ohio State University 5-yr. old fully charged batteries

Cathode crystalline structures remaining after charging **without** pulsing

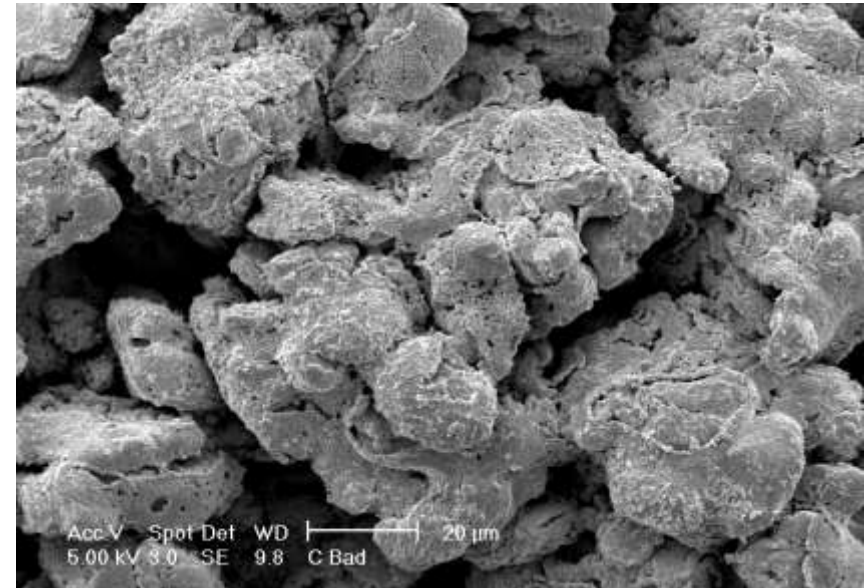
Cathode after charging **with** pulsing

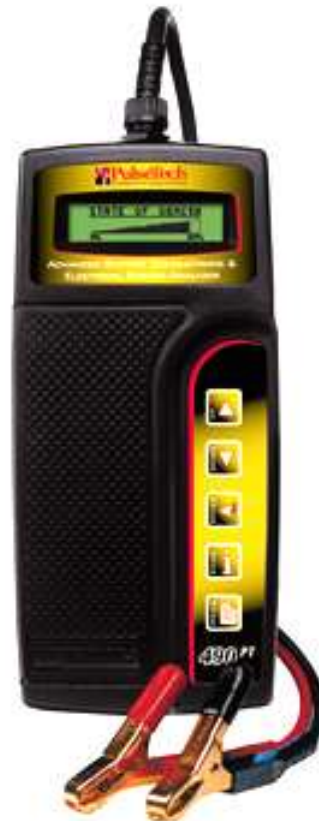
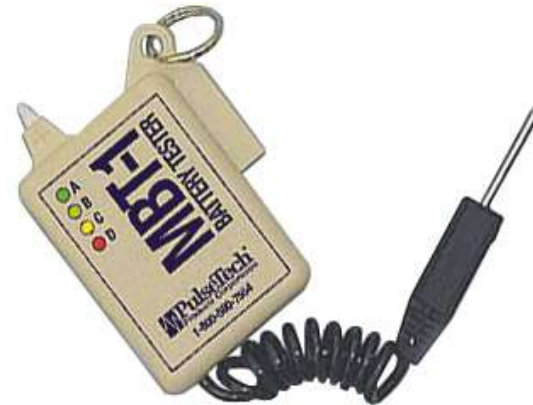
490 PT and MBT-1

Part Nos. 741x490 and 741x800

(NSNs: 6130-01-510-9594 and 6130-01-463-8499)

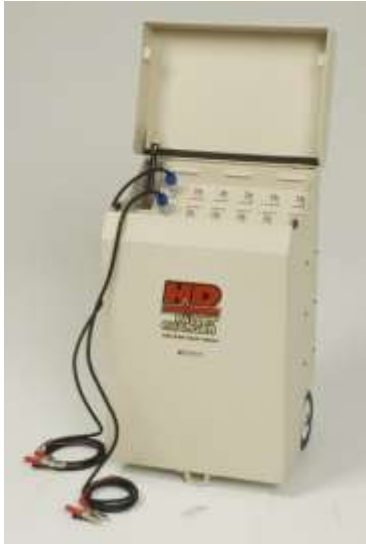
HD Pallet Charger
Part No. 746x820

NSN: 6130-01-532-7711

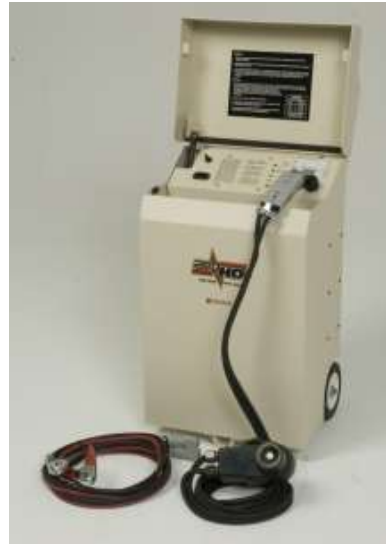
Redi-Pulse Pro HD
Part No. 746x800

NSN: 6130-01-500-3401

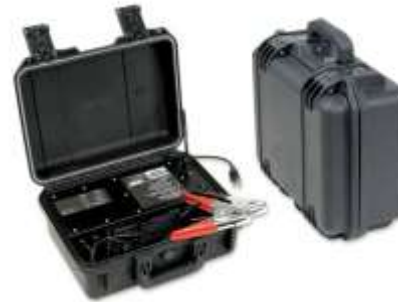
Pulse Charger/World Version
Part No. 746x725
NSN: 6130-01-477-4703
