Results from Air Force Investigation into 20mm Case Neck Separation

NDIA Joint Armaments Conference
14-17 May 2012

Patrick Gray
780 TS/OGMTG
Eglin AFB, FL

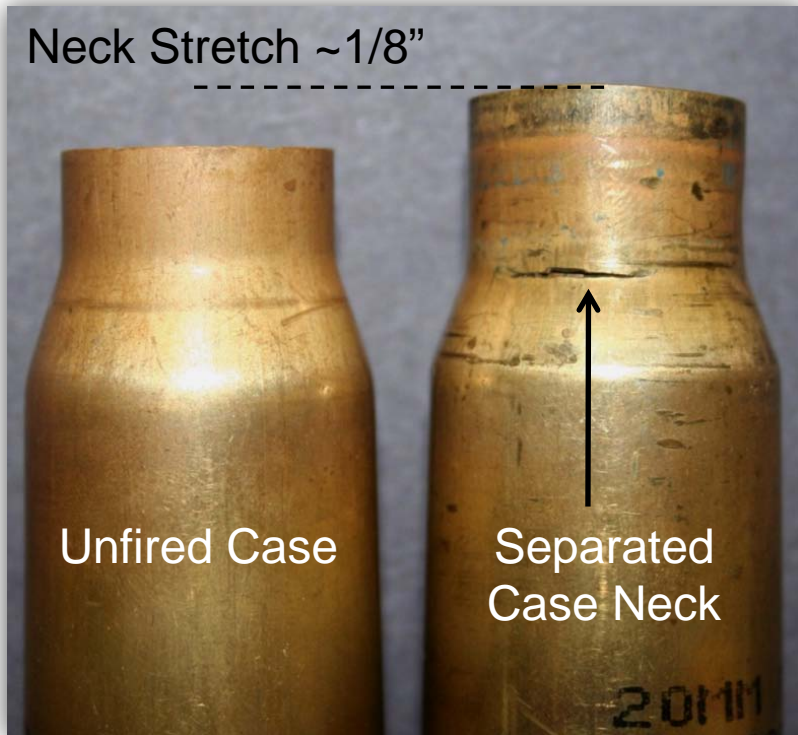
CNS Failure Description

- Tensile failure of M103 brass case in shoulder-neck region during firing
- Excessive loading stretches neck to failure
- Propagates around circumference of neck

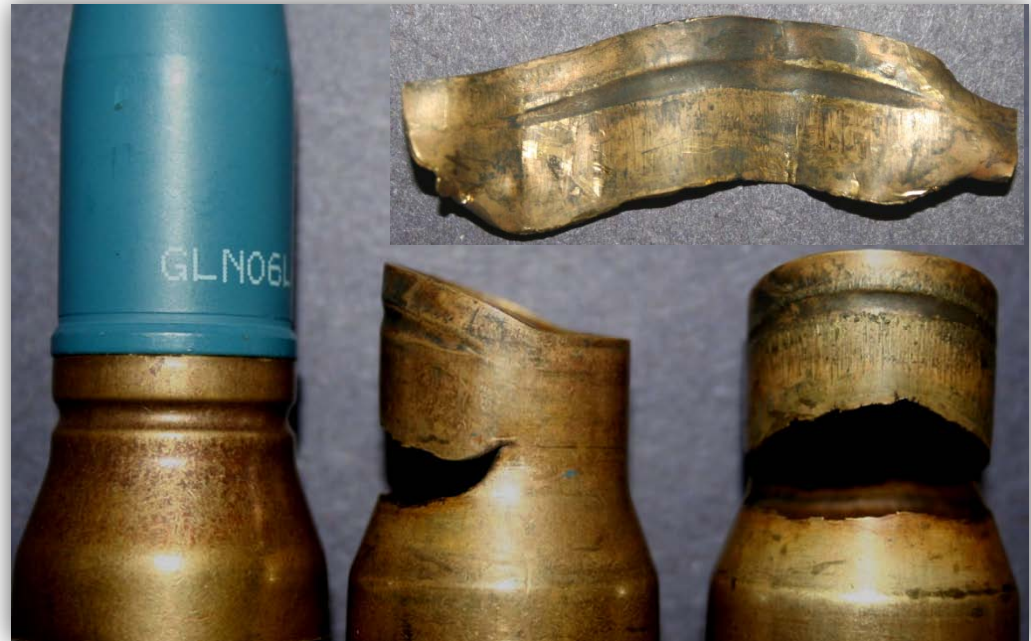
CNS Background

- 40-plus year history affecting all Services
- No root cause consensus
- Crimp groove most likely failure source
- Groove still present post-firing
- Projectile pulling case neck

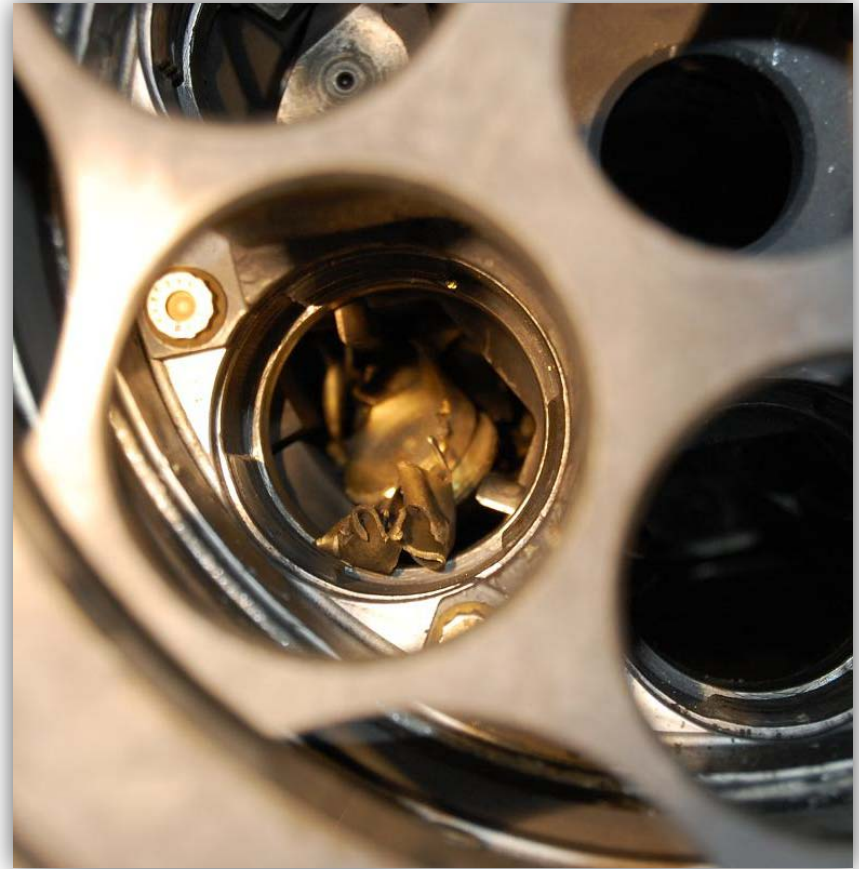
Gun System Damage

- Jams gun due to lack of case control
- “Soft” jam upon ammo download
- “Hard” jam with gun at max firing rate

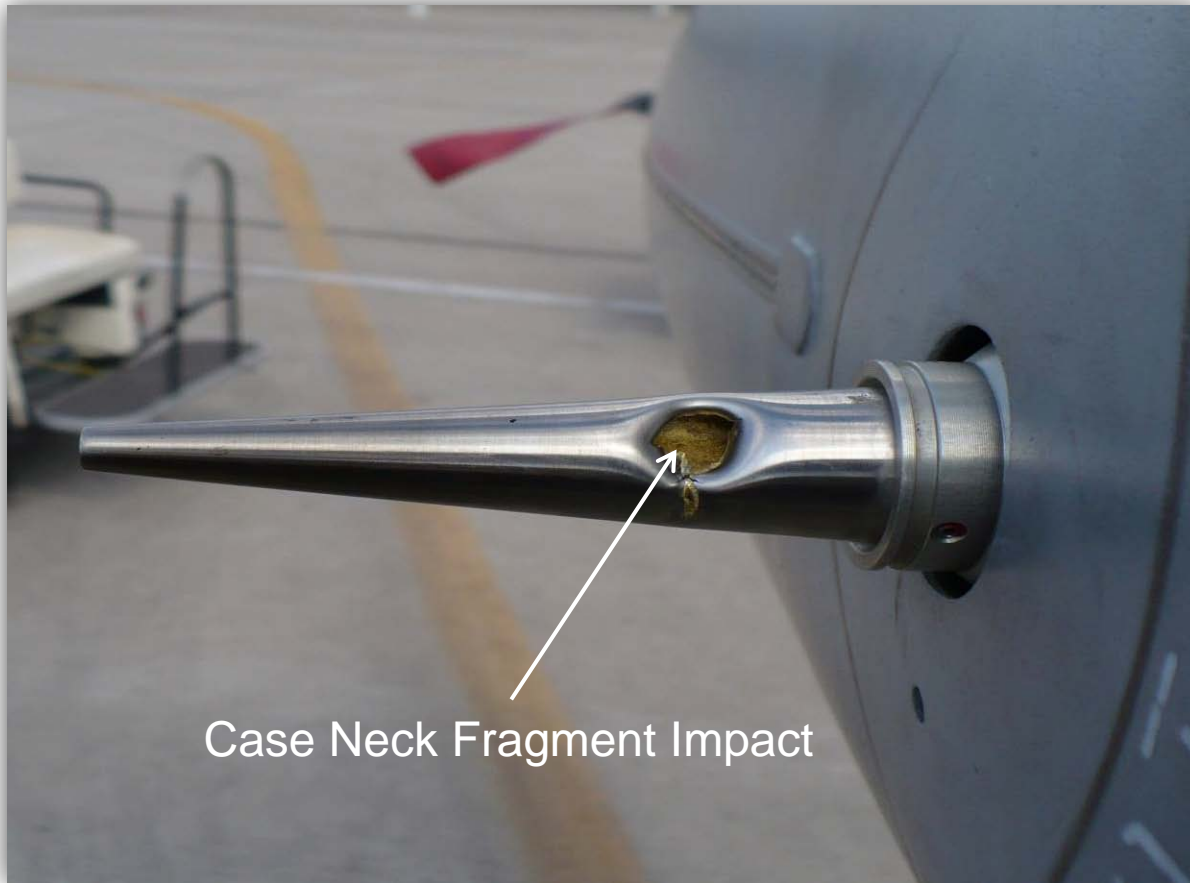
F-16 AoA Probe Damage

Case Neck Fragment Impact

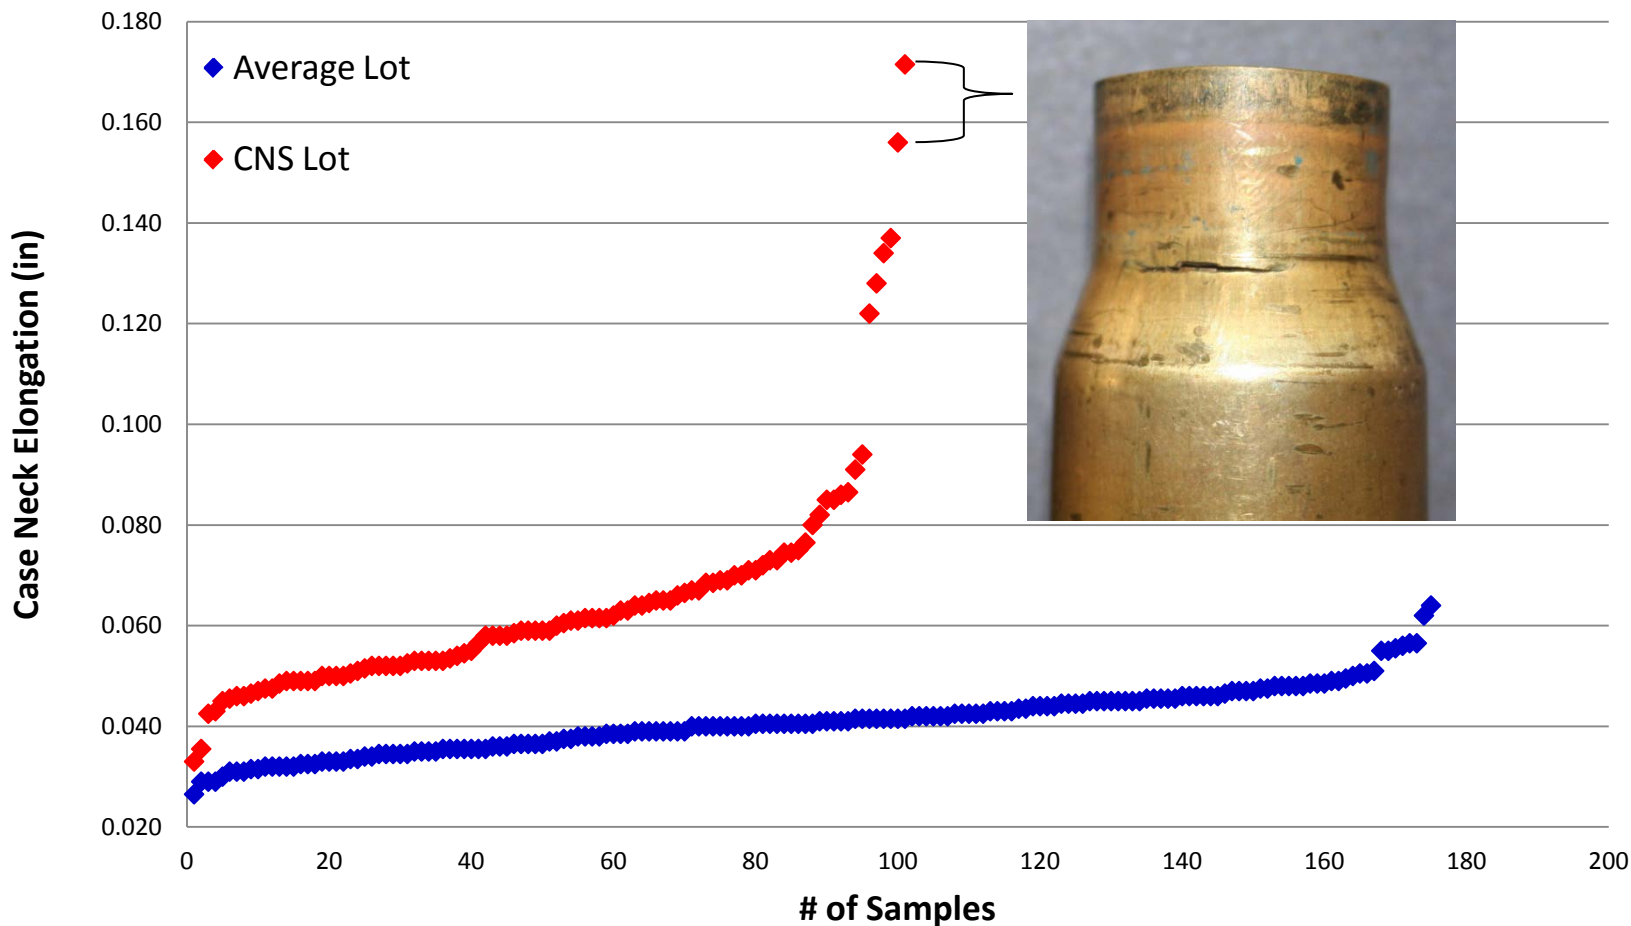
M61A1 Elongation Profile

- Tasked to assess CNS potential in inventory
- Screen via case neck elongation measurement
 - Hypothesis – CNS-prone ammo elongates more
- ~ 200 lots subjected to projectile extraction, single shot and M61A1 burst firing
- Brass from all three tests measured
- 6 lots experienced CNS during test
- Lots assigned risk level 1-4

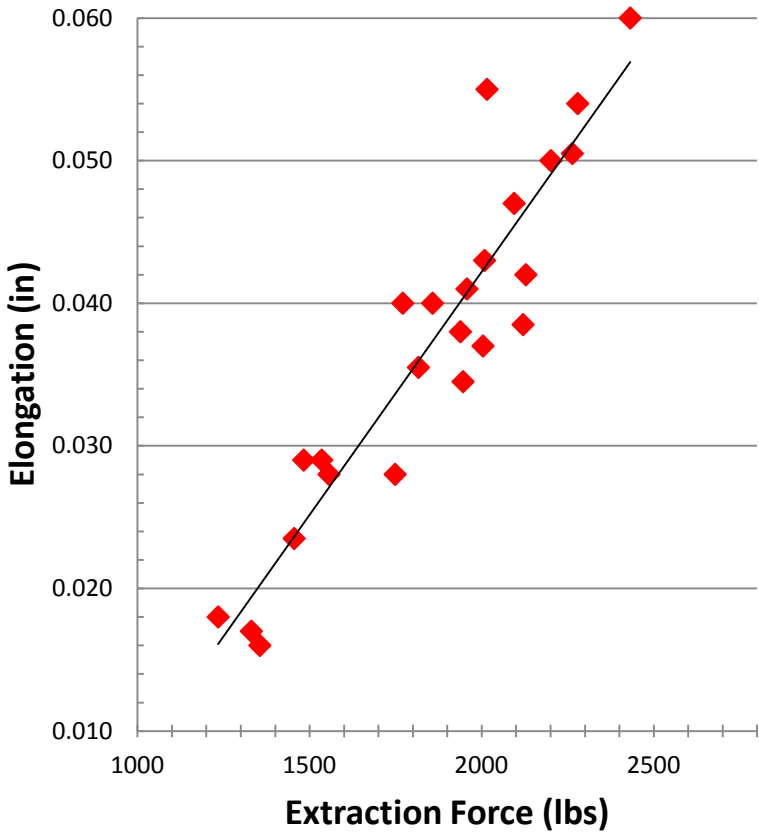
Lot -069

Elongation vs Extraction Force

- CNS lots elongate more than average lots
- Elongation correlated with extraction force
- Higher extraction forces present in majority of historical CNS lots
- Loctite/crimp groove modifications promising

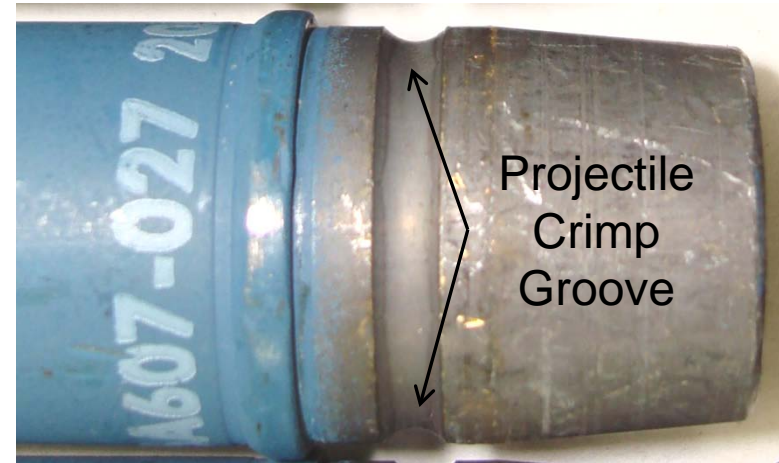
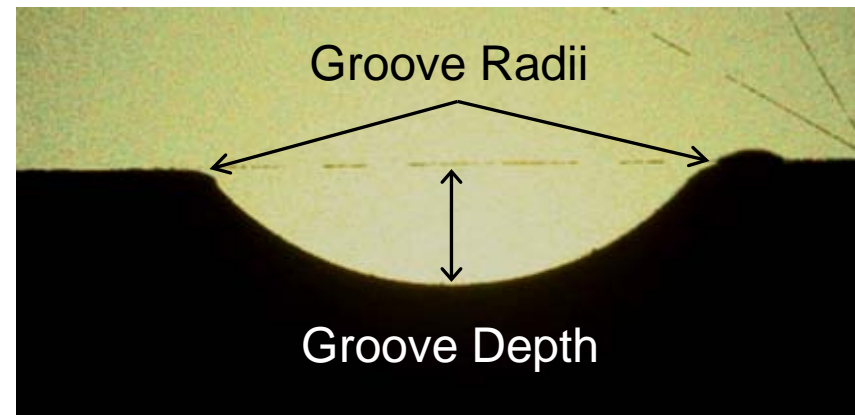
20mm Cartridge Modifications

- Loctite sealant (2010)
 - Reduced extraction force variance
- Modified crimp groove (2012)
 - Shallower groove depth, less sharp radii
- Reduce 2800 lb upper limit – TBD

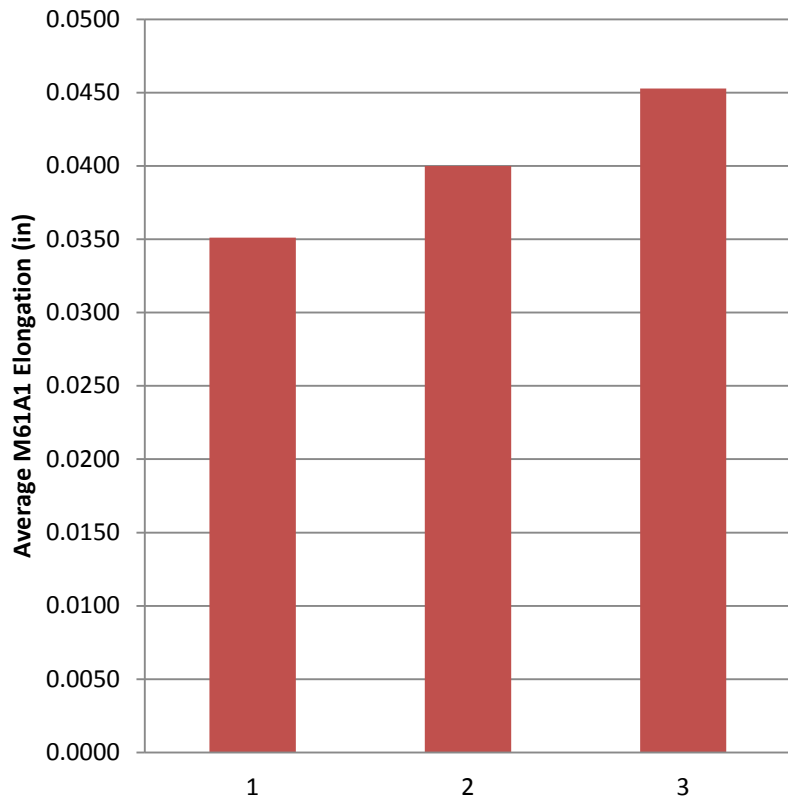
Lot -086

Elongation vs Sample

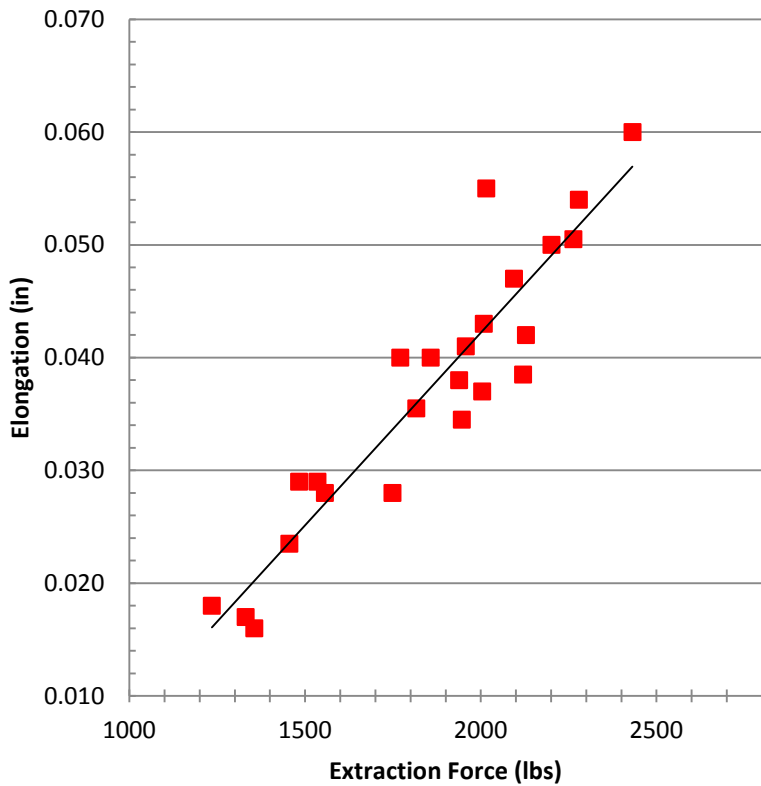
Lot -069

Elongation vs Extraction Force

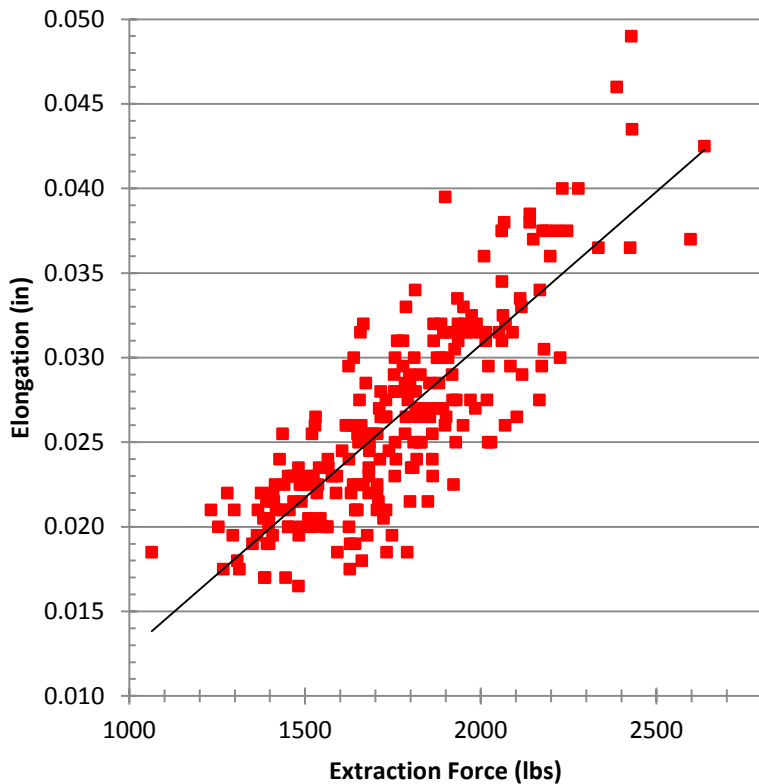
Lot -030

Elongation vs Extraction Force

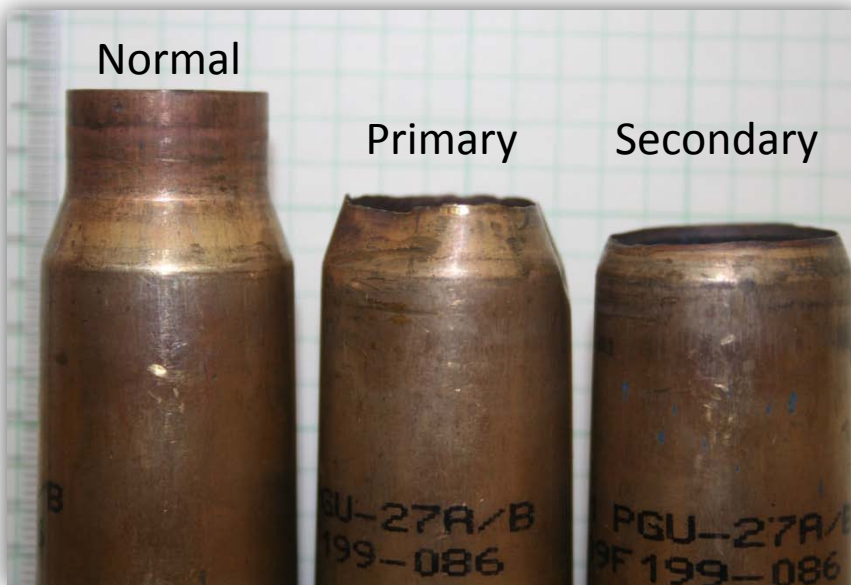
Secondary CNS

- Result of primary failure
- Partial telescoping of advancing cartridge
- Smoother, mid-shoulder fracture surface
- No “dimpling”
